Projects 2004

CV Joint, Engine Mounts, Stern Tube, Switches, Cushions, Dirty Fuel, CV Joint (Again), Aft Station

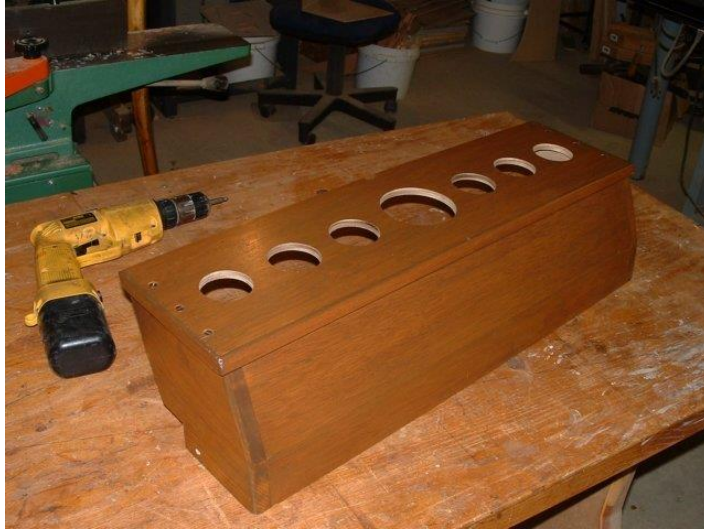
New instrument panel for above the helm station. The old one was too shallow for all the wiring and was too difficult to remove for maintenance purposes.

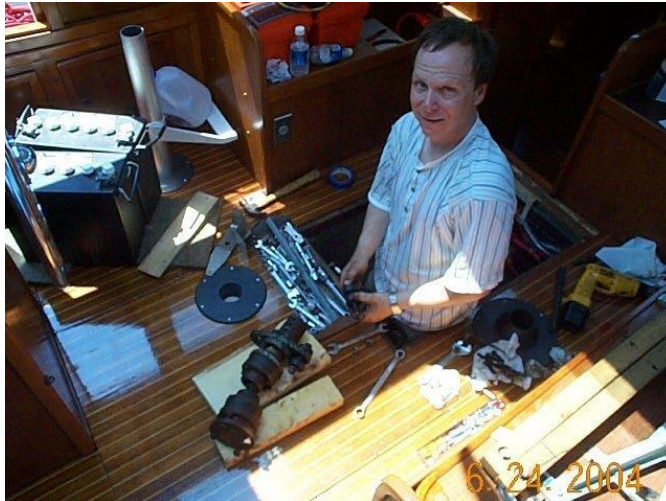
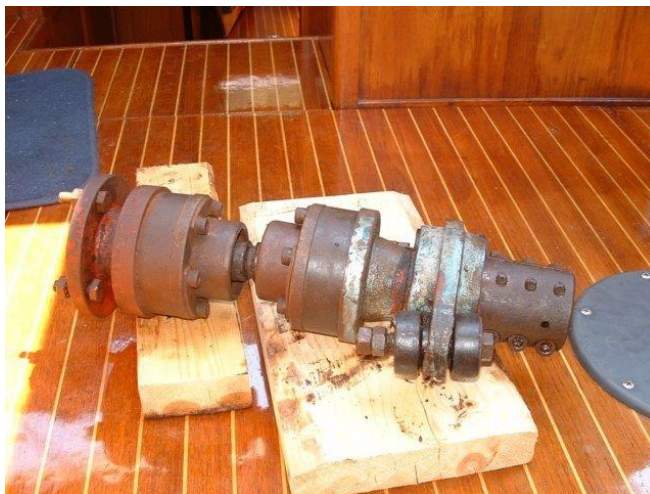
Pulling the Aqua Drive CV joint. We didn't understand why the interior was so noisy when underway. We finally figured out that the bearings were shot in the CV joint. It appears that it was under water in the bilge for a significant time when the boat was for sale.

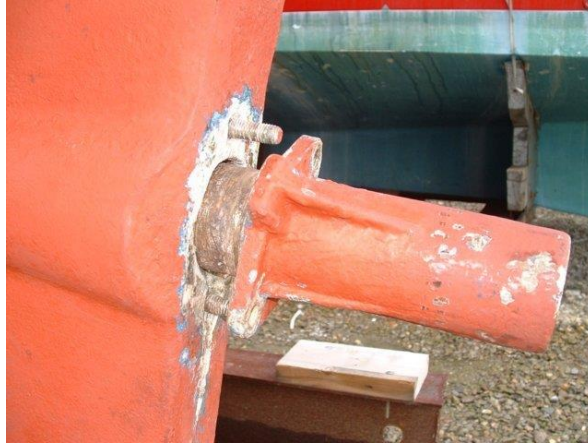
We also realized that the boat was sinking. After replacing the packing in the packing gland with Gore brand packing and essentially stopping any dripping from the shaft, the bilge pump was still coming on occasionally. The bilge is filled with iron and capped with a mortar type substance. Water was seeping up through this. The only place that it could be coming from was around the shaft log. The stern tube was pulled, which also pulled the shaft tube at the same time. There was almost no bedding compound in this area.

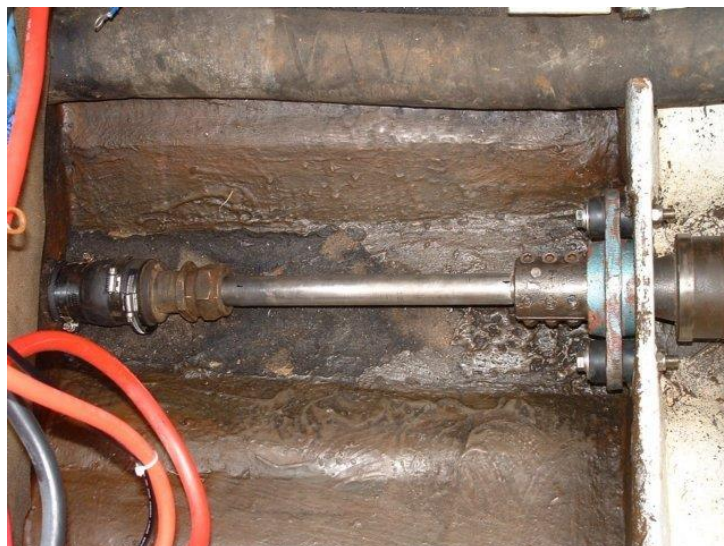
This shows the mini-bulkhead supporting the CV joint and the packing gland. The blackened area shows the region where water was seeping into the bilge from around the prop shaft tube. The bulkhead has since been reinforced with large aluminum angle.

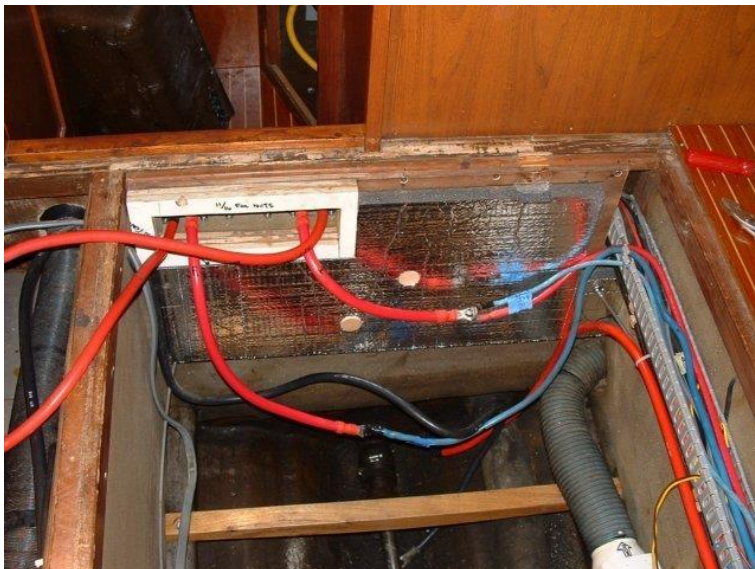
While the batteries were out this seemed like a good time to replace the 1-2-Both switch with three separate switches.

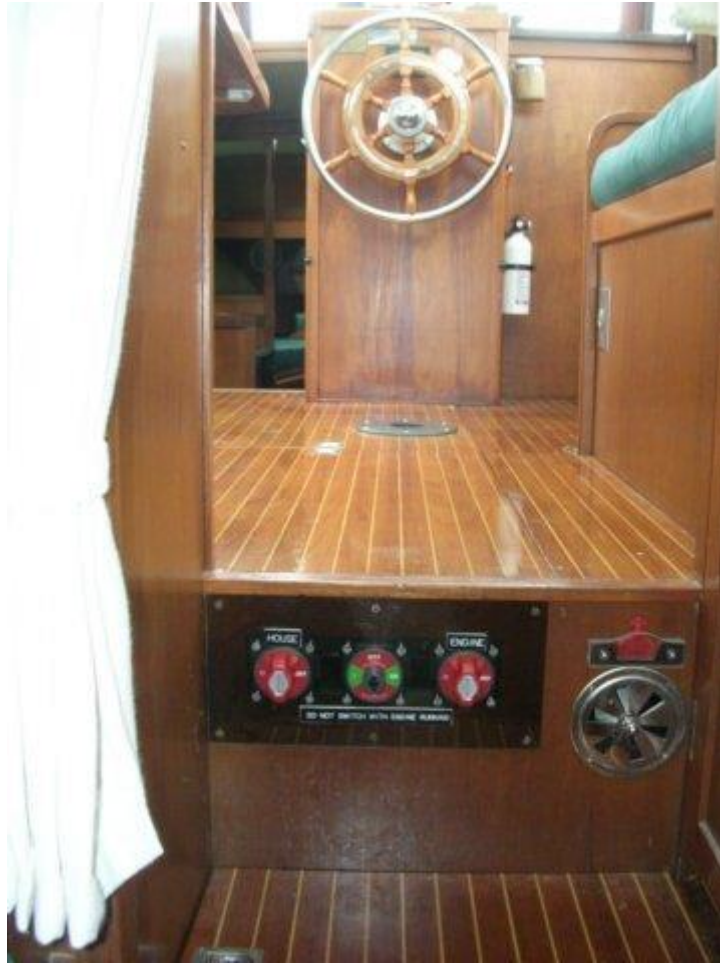
The key above the heater vent should keep anybody from doing something stupid. The house and engine batteries are fully isolated but can be combined if necessary.

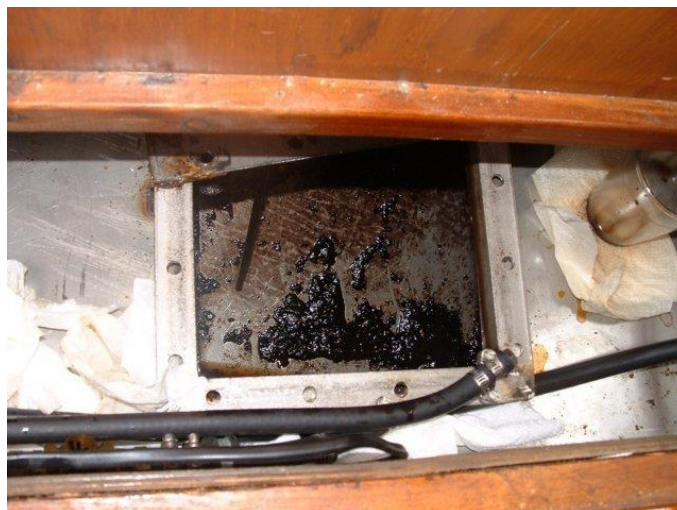
A simple evening cruise got a little too interesting due to dirty fuel issues. A check inside the tank showed why. The tanks were supposedly cleaned two years before we purchased the boat, but either they didn't do a good job or the fuel cruded up the tanks in the two years the boat sat waiting for a new owner.

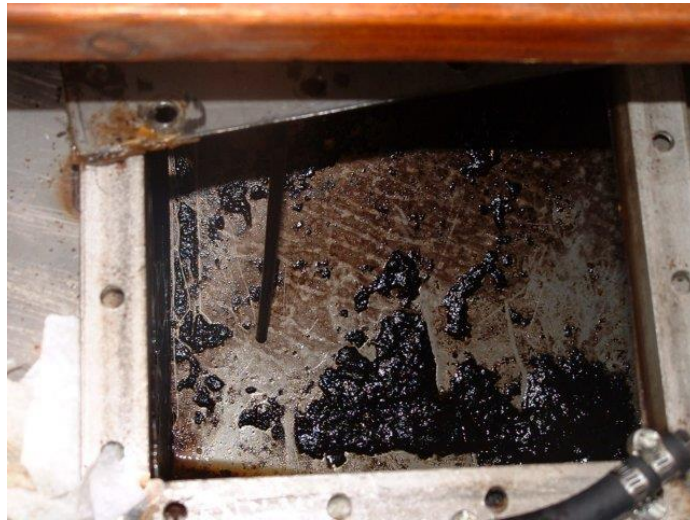
A closer look at the gunk attached to the tank walls.

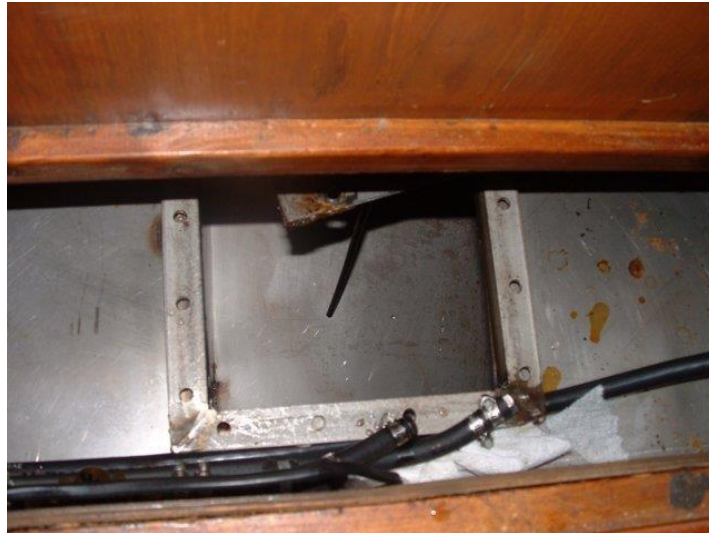
A clean tank.

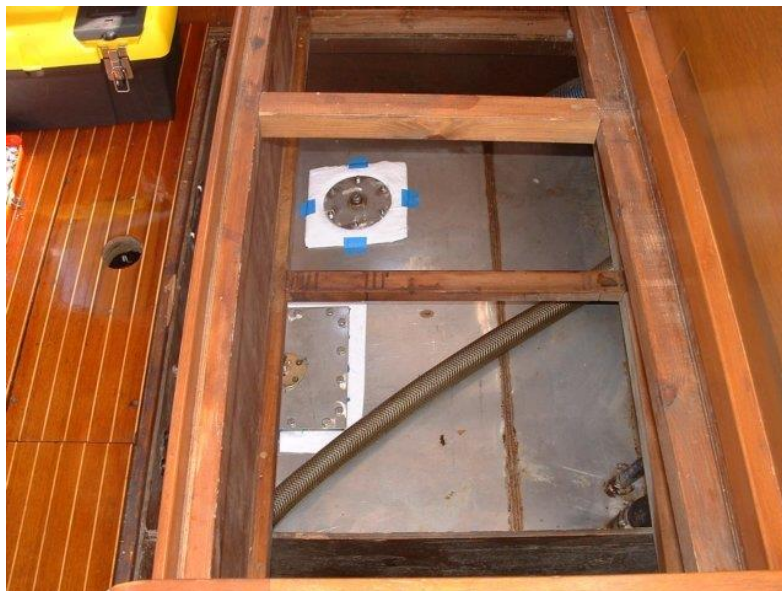
We had to cut another hole (circular) in the tank forward of the tank baffle in order to clean that area of the tank. We then fabricated a cover for that area. Both tanks needed to be cleaned.

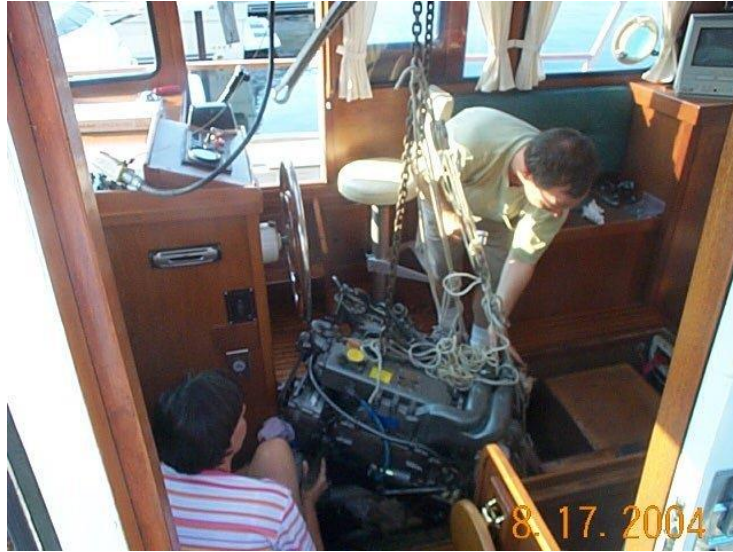
After getting the CV joint back in the boat, we found that one side of the CV joint was overheating. This was due to the fact that the angle of the engine was wrong. In other words, the motor mounts needed to be shimmed. Remember, this is a replacement engine that only had 30 hours on it even though it was in the boat for almost 10 years. So, out with the engine.

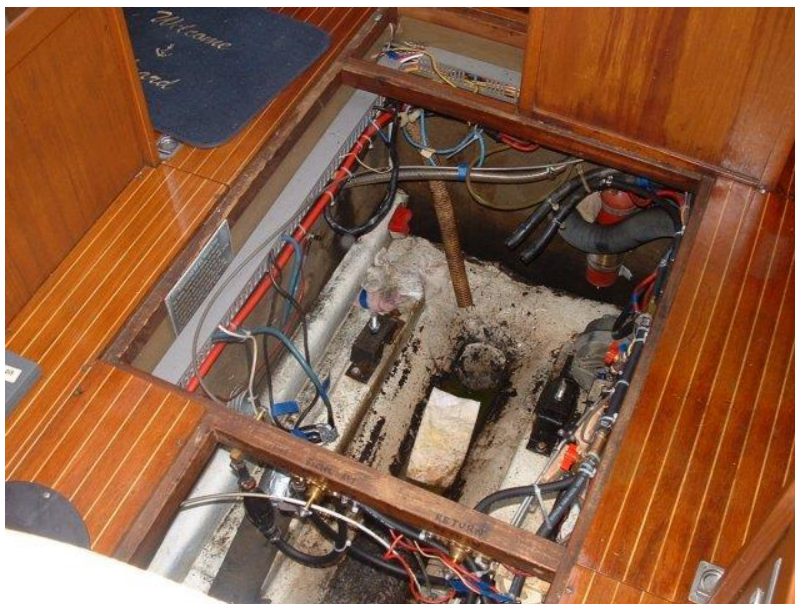
Bilge without the engine; it was quite the mess.

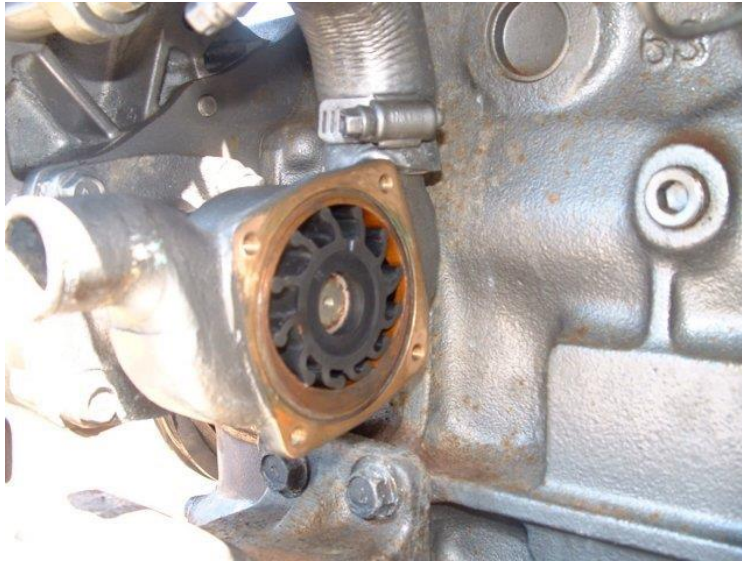
New impellor. Yanmar likes to put their water pumps in locations that are not easy to access.

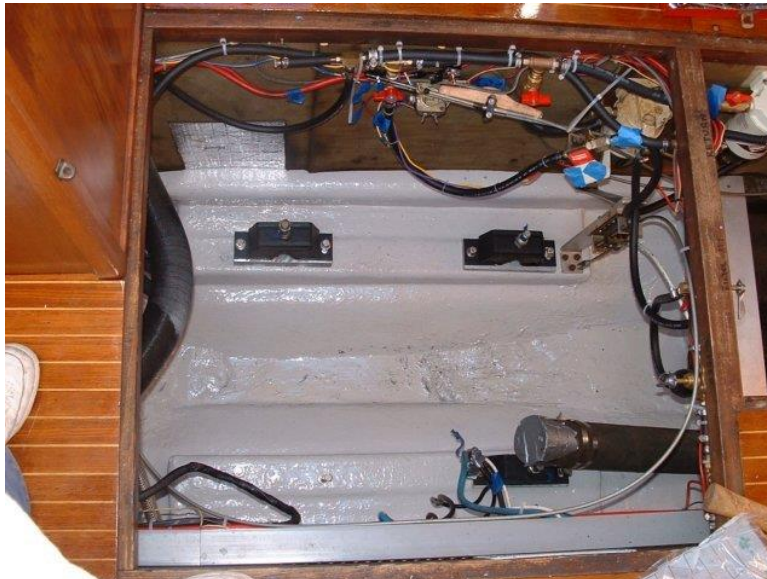
We were able to clean and paint the bilge while fabricating the shims for the mounts.

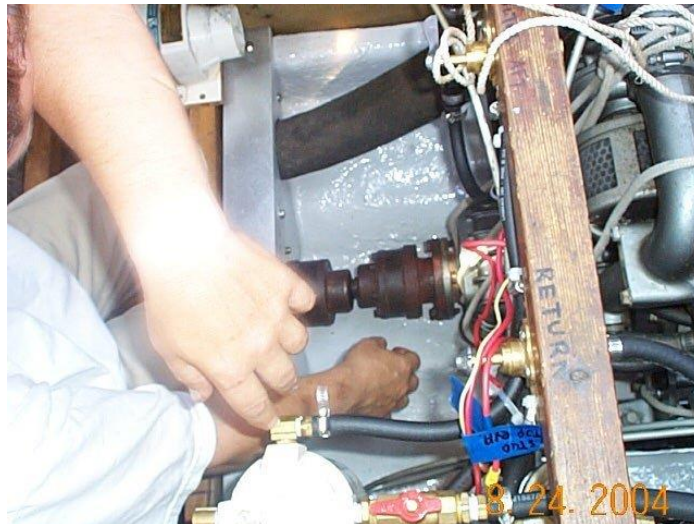
Re-installed and re-attached to the CV joint. The CV joint now stays cool when running.

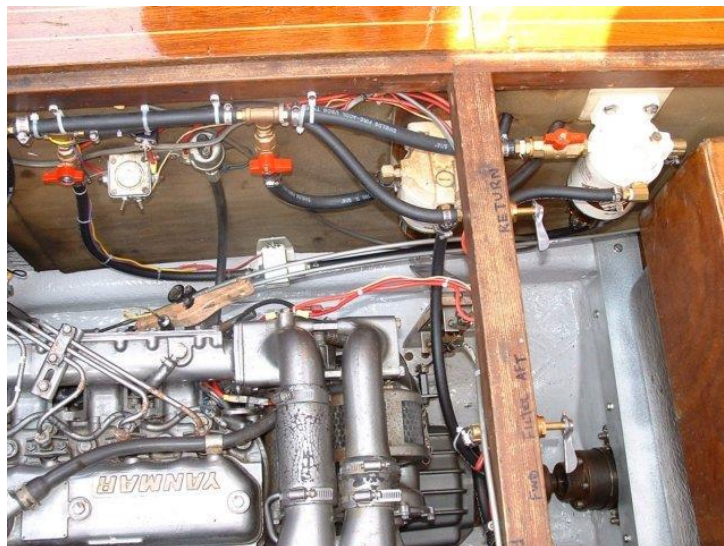
Two Racor fuel filters were installed so that we can switch filters while underway. Coming from sail you get paranoid about making sure that the (single) engine is getting clean fuel as fuel delivery problems are about the only thing that can kill a running diesel.

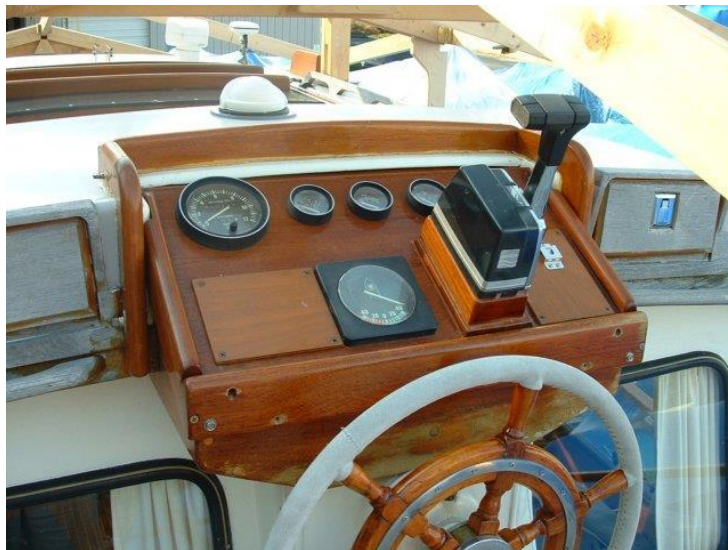
The box and controls at the aft steering station didn't appear to be original and needed to go. The box was going to be in the way of the steadying sail mast that was planned.
