Refit Spring 2003

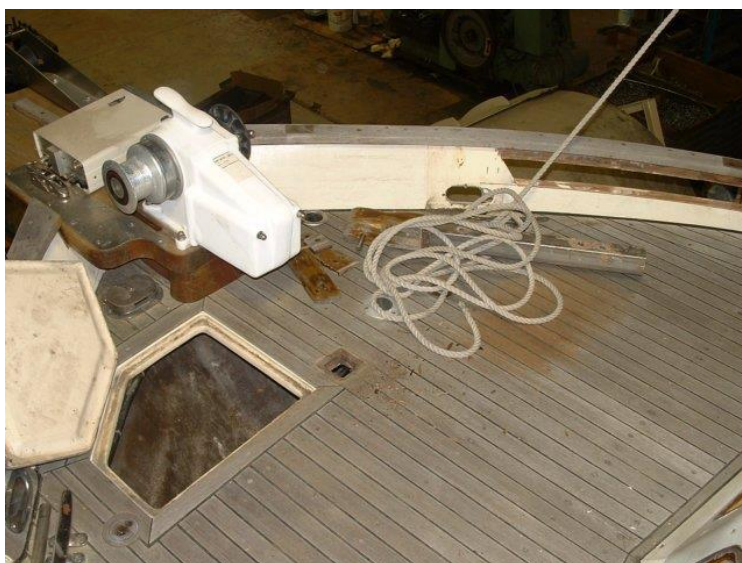
Front deck with starboard rail rot removed

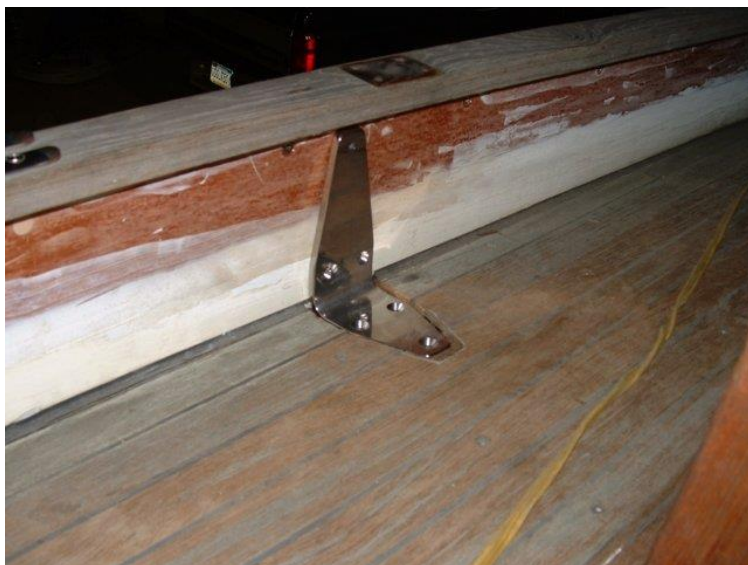
The toe rail, while stiff enough as a low rail, flexed too much with the wooden handrails. Several stainless brackets were fabricated to help support the rail.

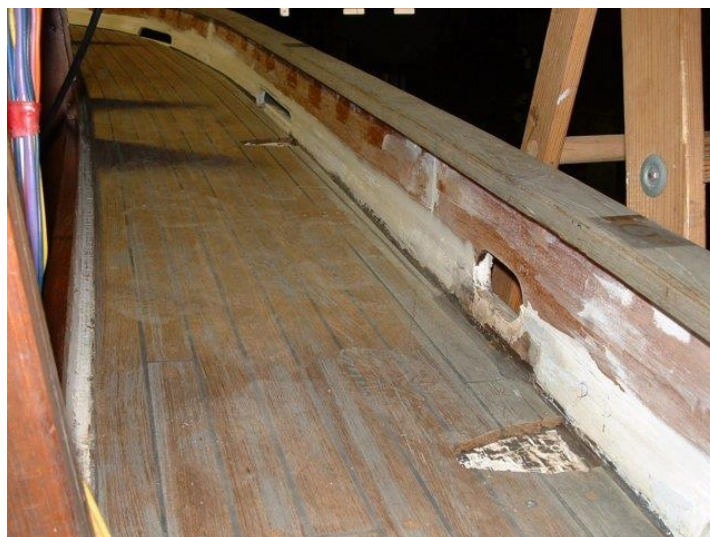
The new plywood was installed with Sikaflex. It should make replacement easier when that time ever comes.

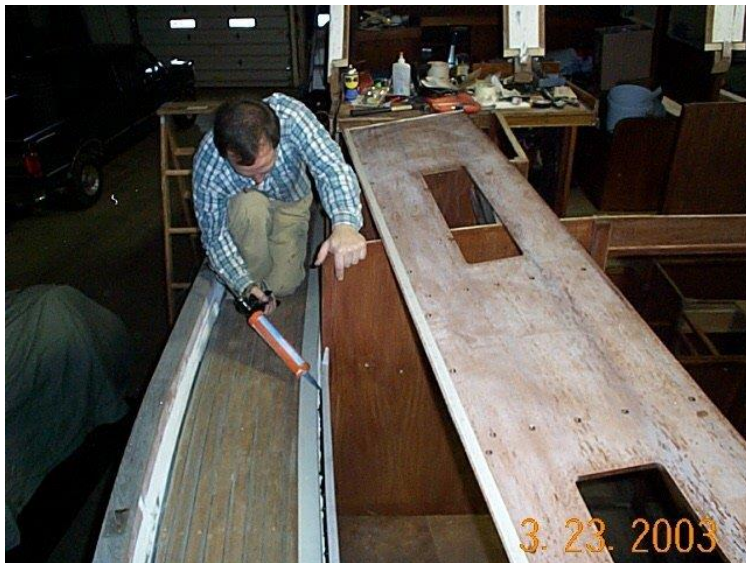
Massive amounts of Sikaflex were used to bed the new cabin sides. The cabin sides were epoxy coated with special attention paid to the end grain.

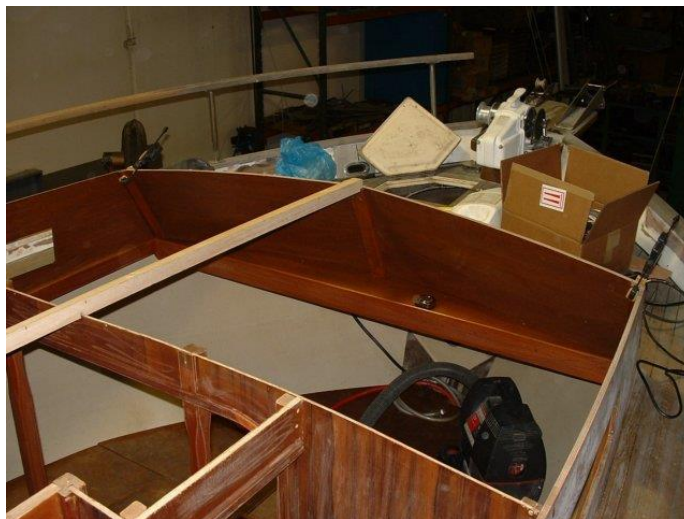
Fitting the new forward cabin front. Originally there were ports installed in the facing forward. It was decided to eliminate these during the re-build to reduce any possible leakage issues.

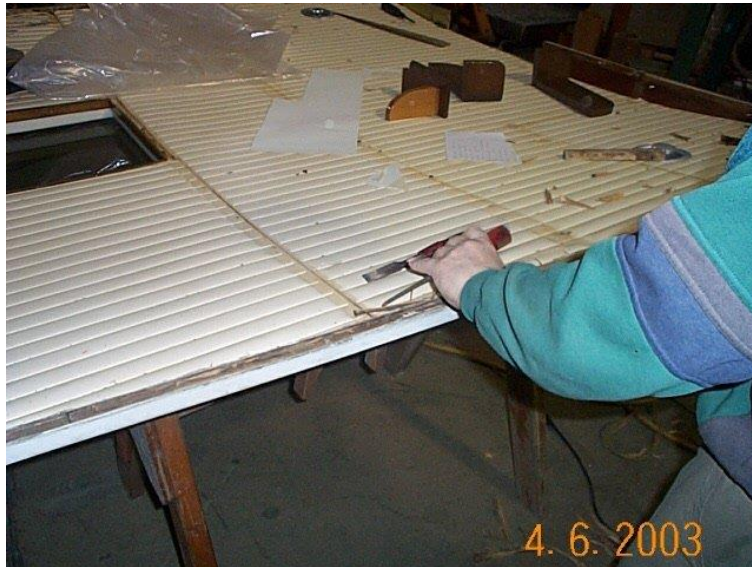
Removing the rotten wood in the perimeter of the forward cabin roof. This wood was replaced with cedar.

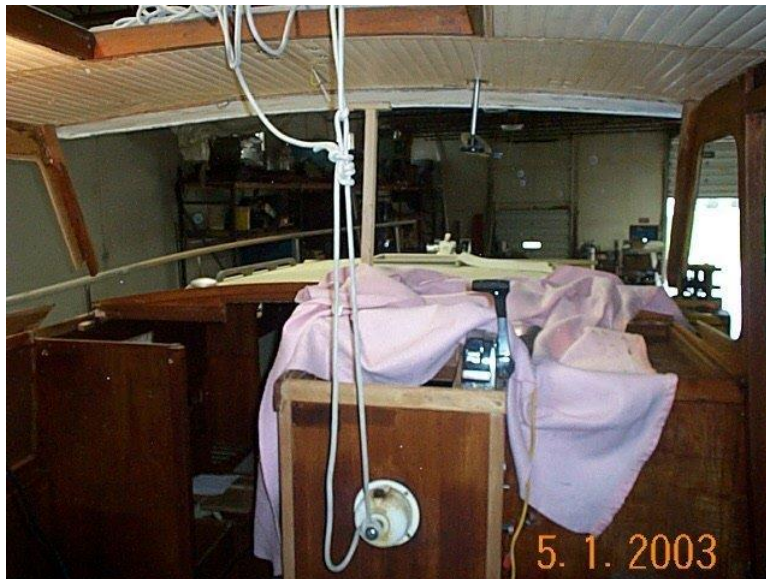
We have gone this far so it was decided to replace all the main salon forward window port framing.

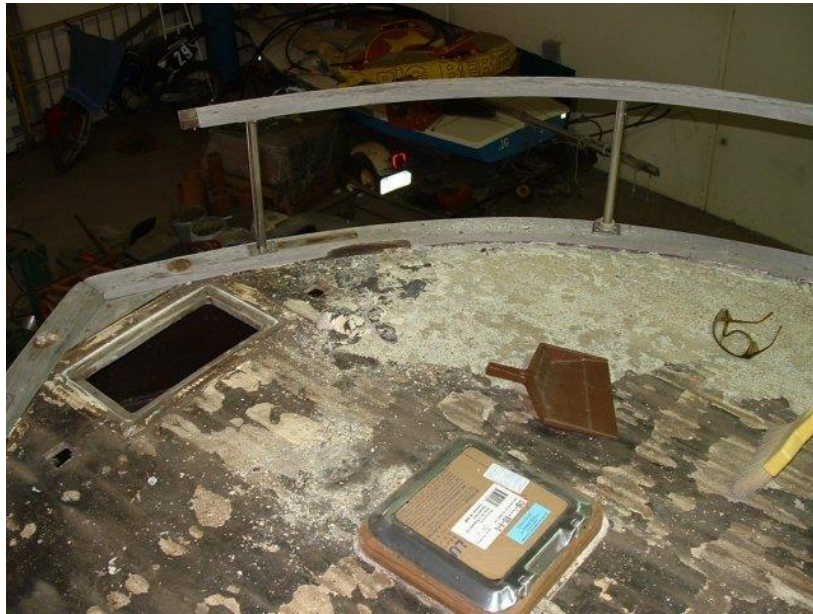
Working on the back deck. The teak was stripped off and the failed gelcoat is being removed.
