Refit Summer 2003

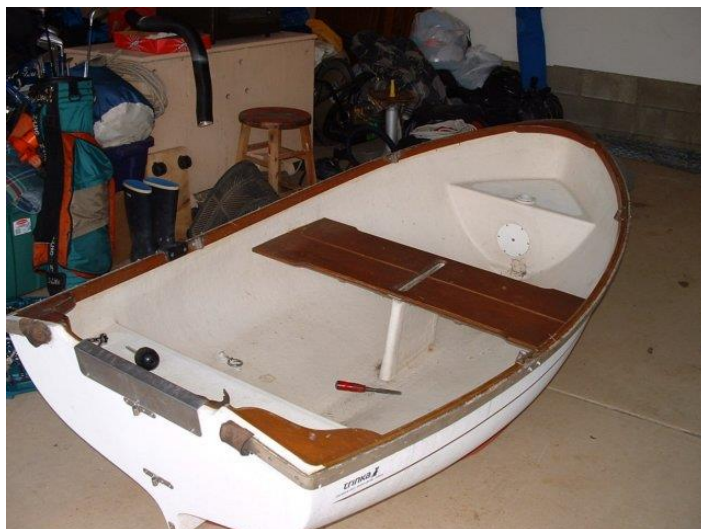
Trinka sailing dingy that needed a bit of work.

Teak sanded and varnished (Sikkens) and a new rub rail installed.

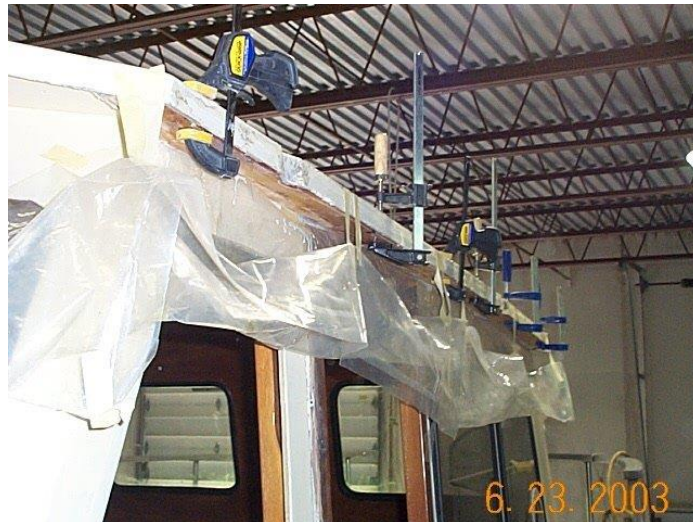
The underside edges of the main salon house were rotten. The rot was dug out, and the wood was replaced with cedar and a white oak cap.

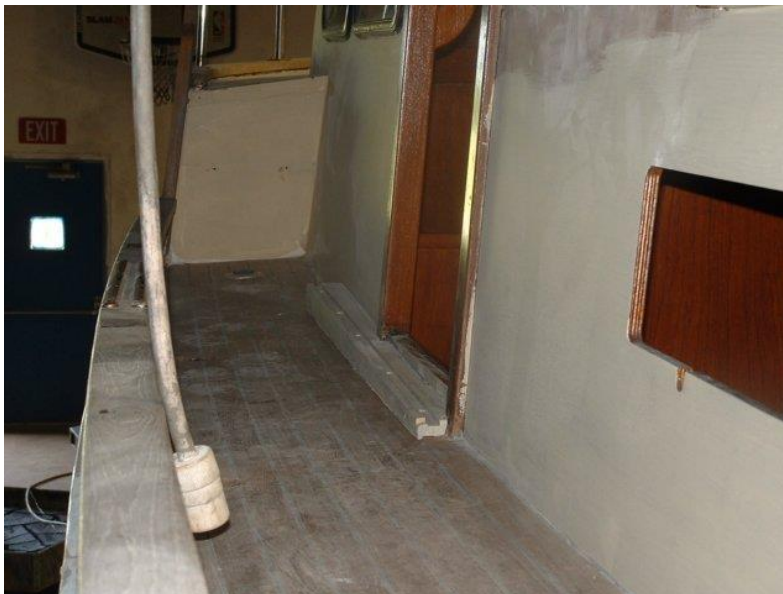
The door slides were rotten teak and had to be replaced. We used locust.

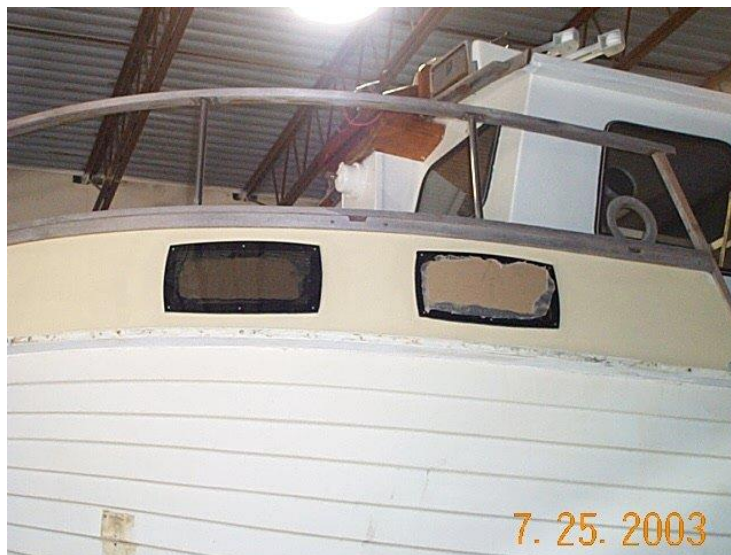
Lexan ports were fabricated and glued to the hull using Sikaflex 295 UV making sure to use the appropriate primer. The interior paneling in the aft head was ruined by leaking opening ports. We added a hatch in the aft deck for ventilation.

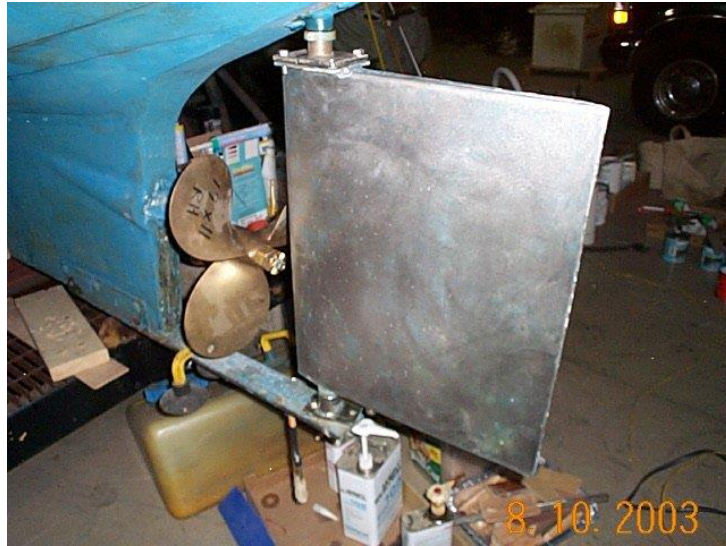
A temporary prop was installed while we figured out what to change the pitch to on the original prop. The rudder post was also replaced as there were crevice crack issues with the original.
