Refit Winter 2002

Once we had Finlandia (ex Wallabash) inside we could start to tear into her, pretty much knowing that one thing would lead to another.

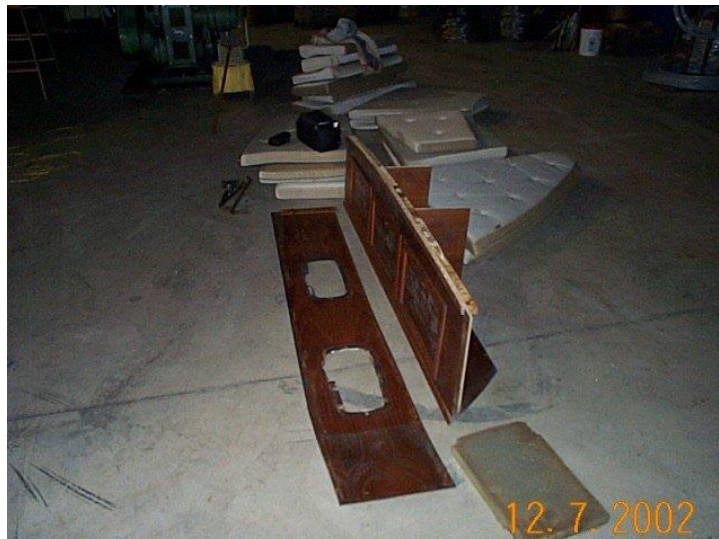
We started gutting the aft cabin. Leaking ports had ruined the plywood.

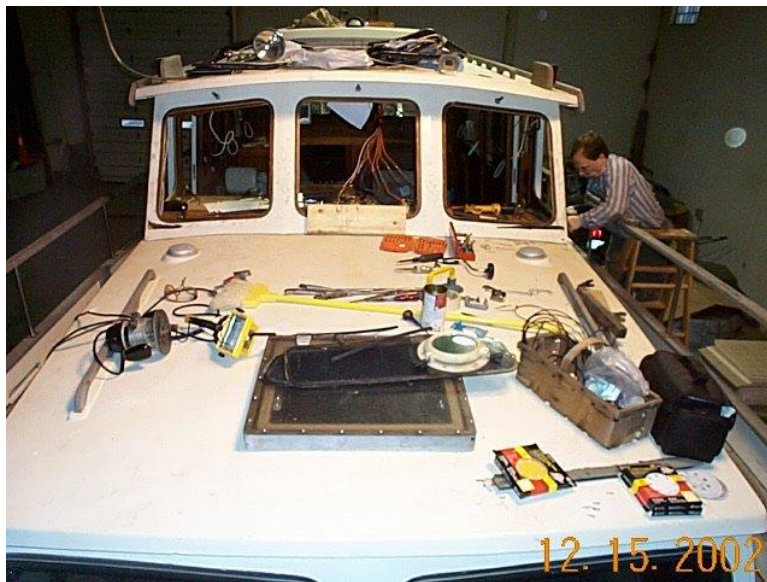
We were still under the illusion that we could “fix” things without major surgery.

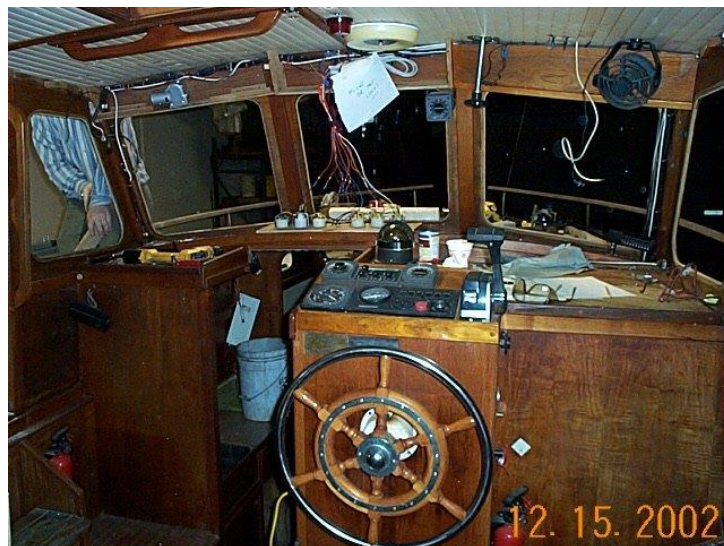
The more you get into things, the worse it gets.

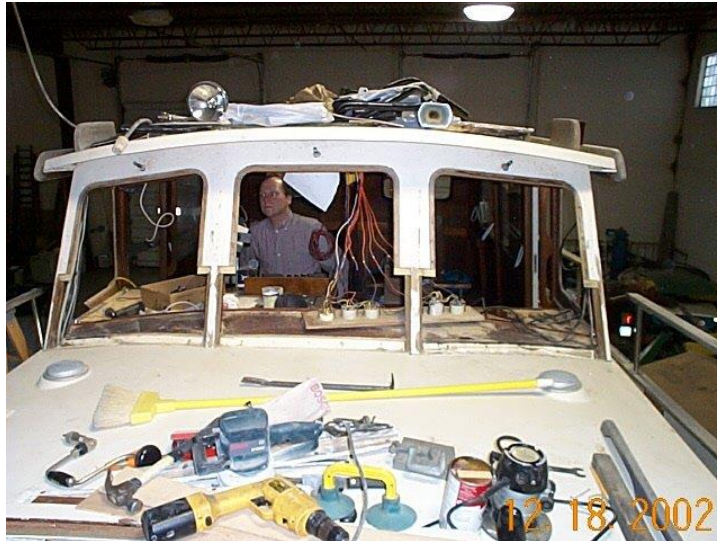
The lower portion of the pilot house windows were all rotten requiring replacement.

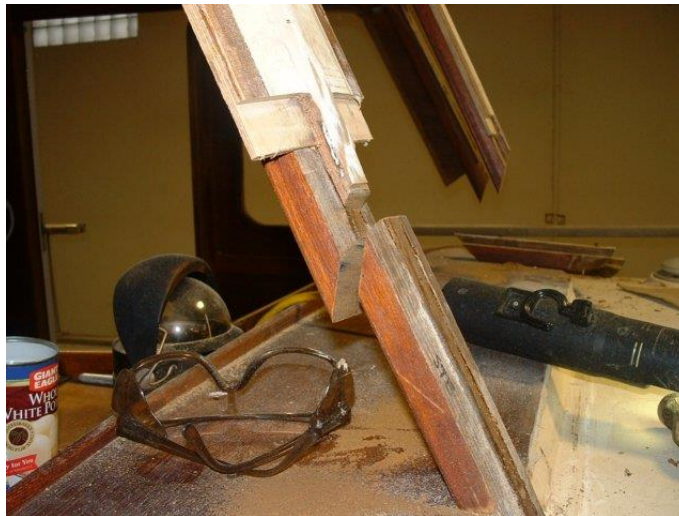
Reality begins to set in. Since we were inside this was the one and only chance to do it right. It was decided to remove the entire forward cabin roof in order to essentially replace all of the forward cabin sides as well as the cabin front. To do this the structure around the forward windows needed to be cut. When we did this you can see how much the house roof "sprung".

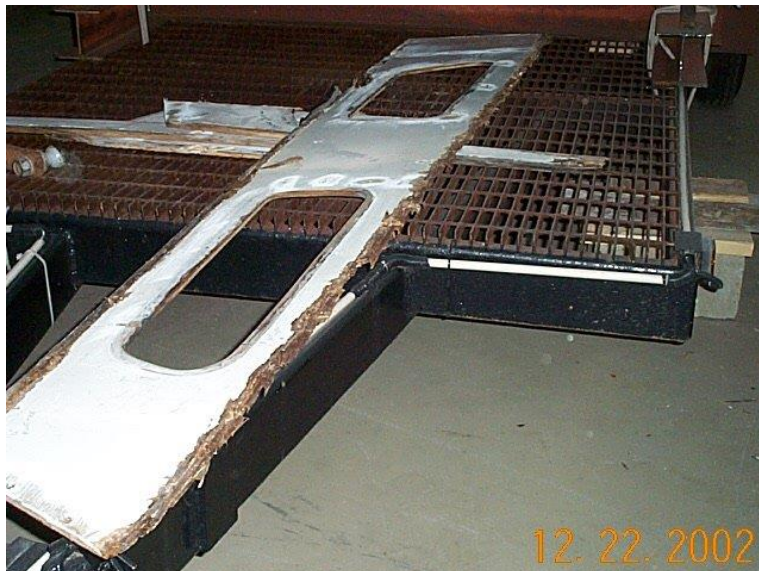
Notice how rotten the lower edge of the old cabin sides were. Removal was not all that difficult.

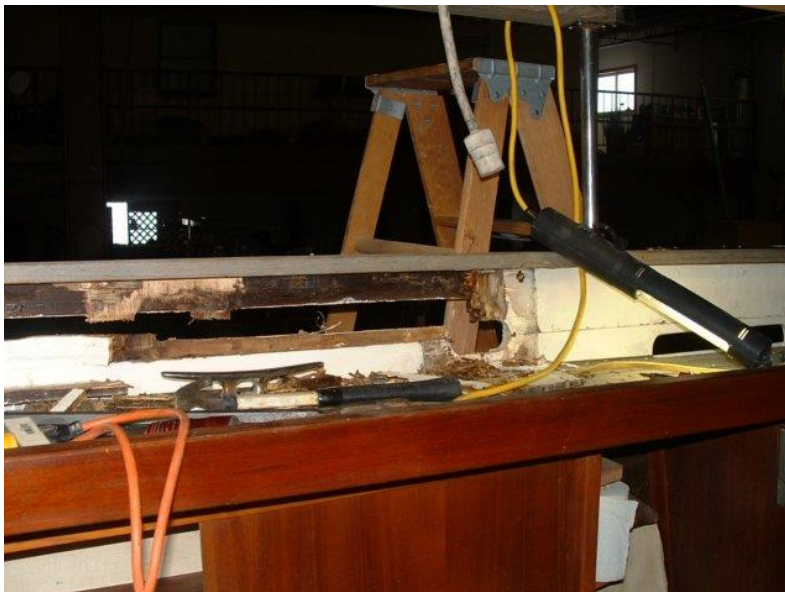
There was a lot of rotten wood in the rails.

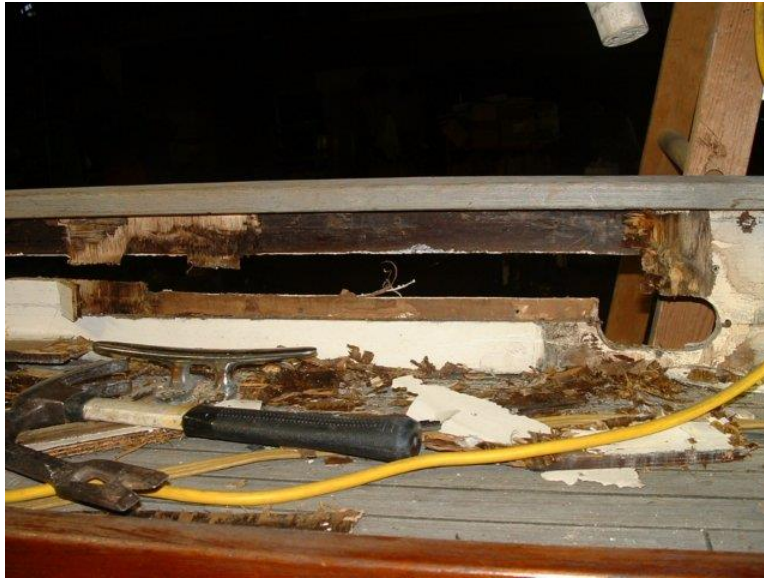
More rot.
