Projects 2005

CV Joint, Holding Tank, Computer, Aft Steering Station, Covers, Steadying Sail

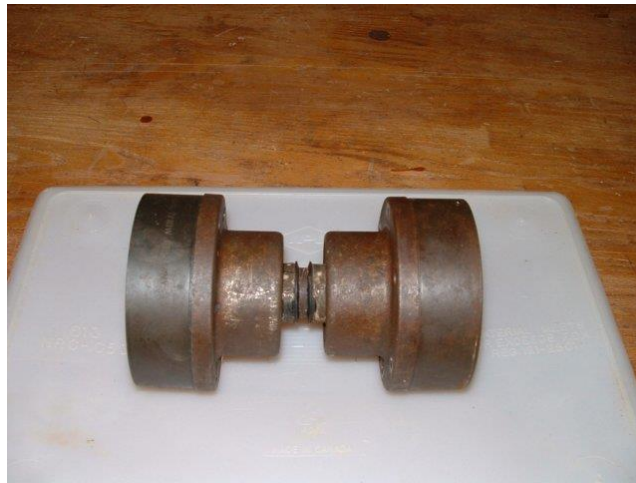
The CV joint is out of the boat again. The rubber boots had deteriorated and were leaking grease, which gets sprayed around the bilge as the joint rotates.

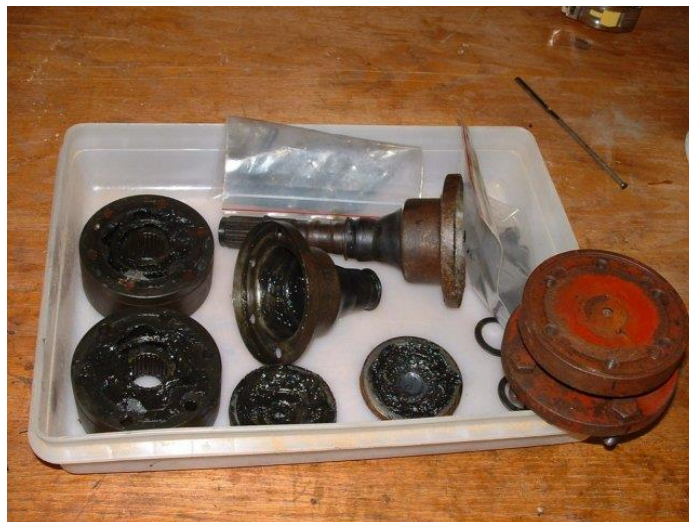
Disassembled CV joint

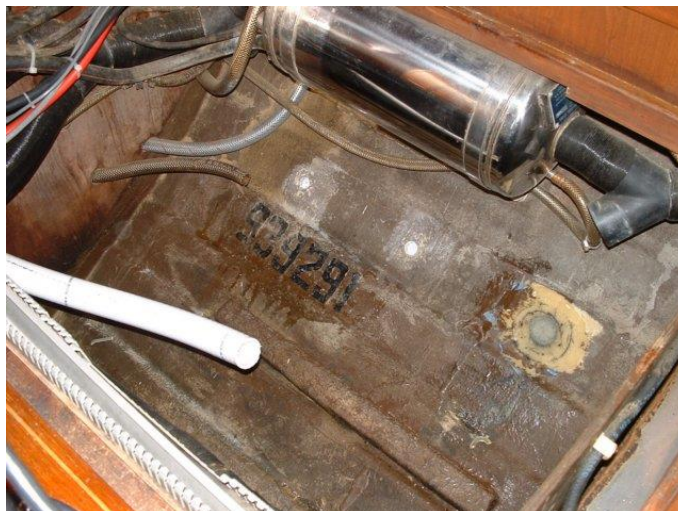
The original holding tank was nine gallons with a macerator pump. The Great Lakes are zero discharge areas, and a nine-gallon tank is way too small. The large hole for the discharge was patched and sea cocks replaced on the inlets.

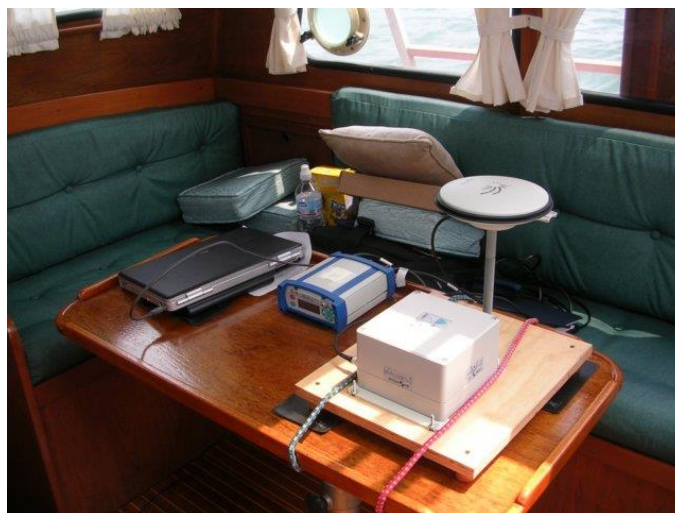
We found the boat is invisible to fairly inexpensive radar. This is instrumentation for recording position, roll, pitch and yaw that was to be used to track the boats motion for comparison against the radar information for a Homeland Security research project. We eventually had to hoist one of the inflatable radar reflectors to track the boat. We tried one of the Davis aluminum reflectors without success.

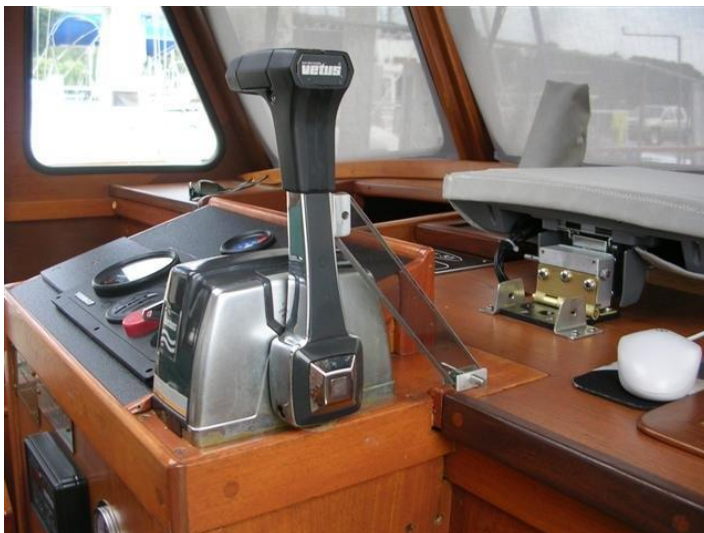
We were having problems with the dual single lever controls behaving with the "combiner" and the very stiff multi-plate clutch on the Yanmar 4jh2dte engine. This was an attempt to keep the levers under control. The levers were not the real issue in the end.

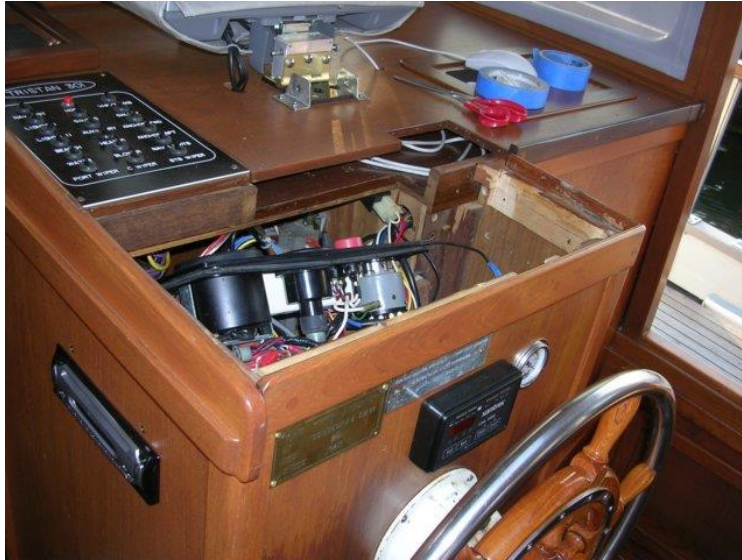
After putting a hole in the dingy, tearing out a piece of the dingy gunwale, breaking a 1/8" SS cable on the dingy bridle and tearing up the dingy cover, we realized that the only real fix for the shifting issue was to install dual lever controls. This requires a re-build of the steering stations (again).
