Projects 2006

New Engine, Instruments, Air Conditioner, Ports, Stove, Table

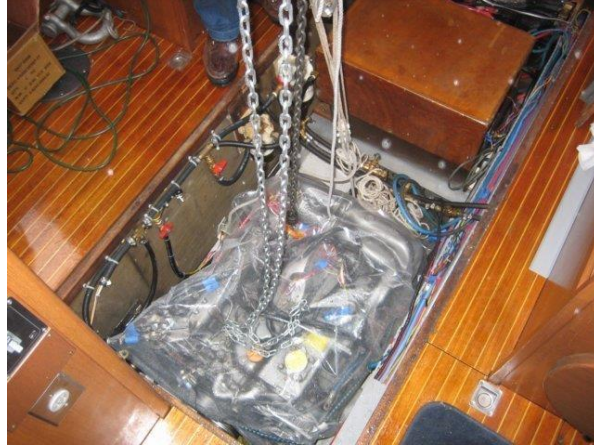
Let's play change engines. The boat originally had a Perkins 4-108 which was replaced with a Yanmar 4JH2-DTE (turbocharged, intercooled, 88hp). Since this was way too much engine for the boat, we decided to replace it with something a little smaller and simpler. Step 1 was finding somebody who was looking for a good deal on an engine with low hours. That was easy as an Albin 27 was looking for exactly this engine.

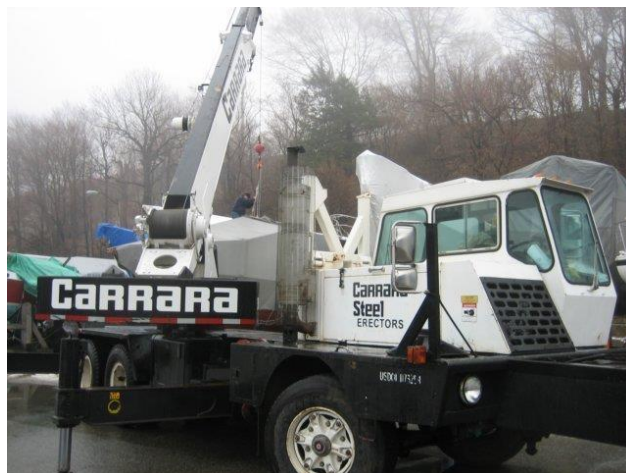
Step 3. Find a suitable crane, or at least a crane that wasn't busy that day.

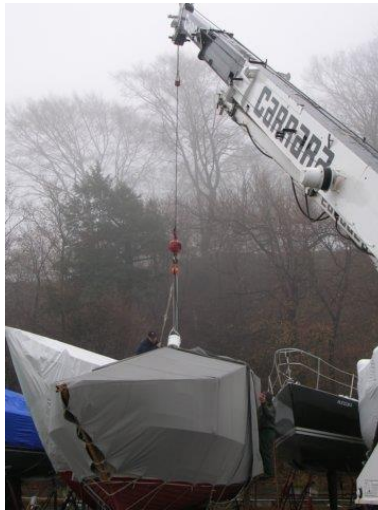
Step 4. Open up the cover, modify the cover framework to allow access to the engine and hook on.

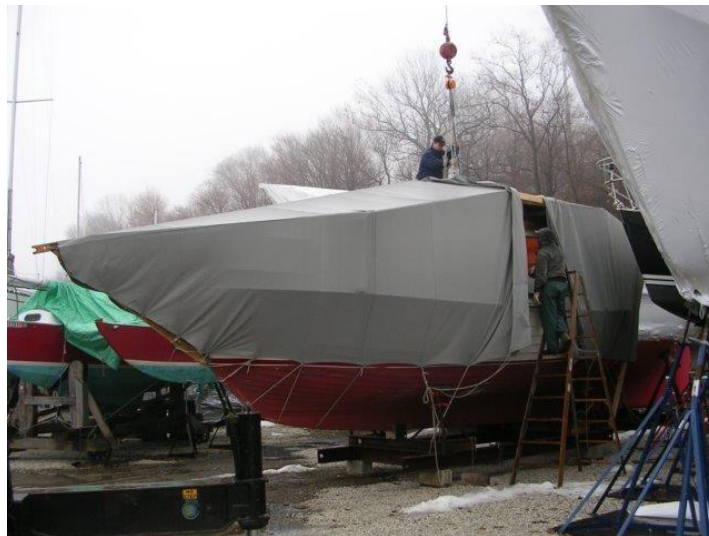
Step 4 (some more)

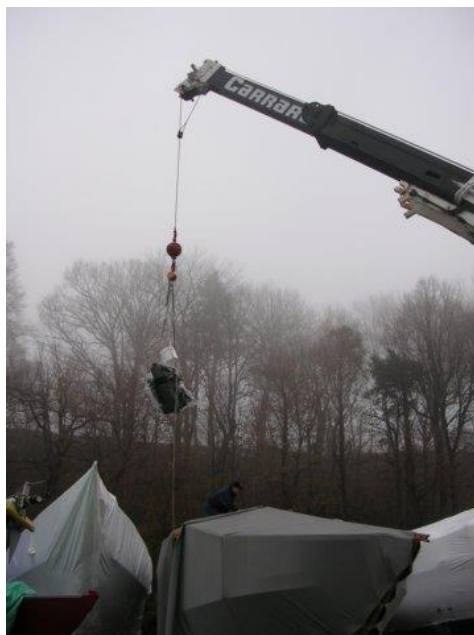
Step 5. Hoist it out.

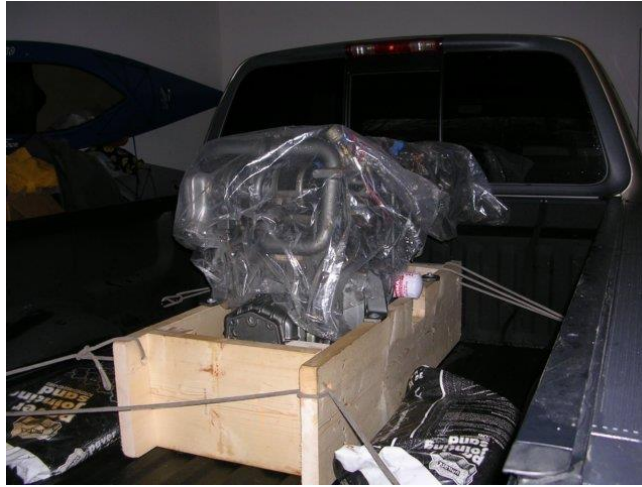
Step 6. Load it up for delivery. Goodbye 88hp 4JH2, hello 52 hp Yanmar 4JH4E.

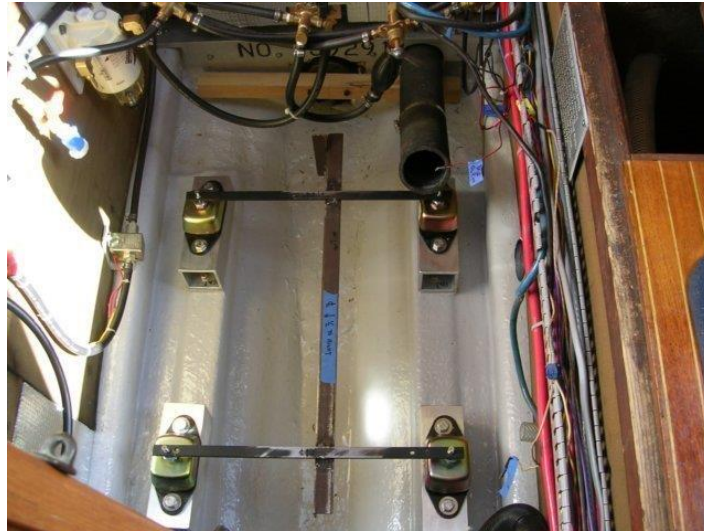
Step 7. Make a jig to exactly align the (in)correct engine mounts that are mounted on square aluminum tube so as to use the original mount holes (drilled and tapped into steel plates glassed into the hull).

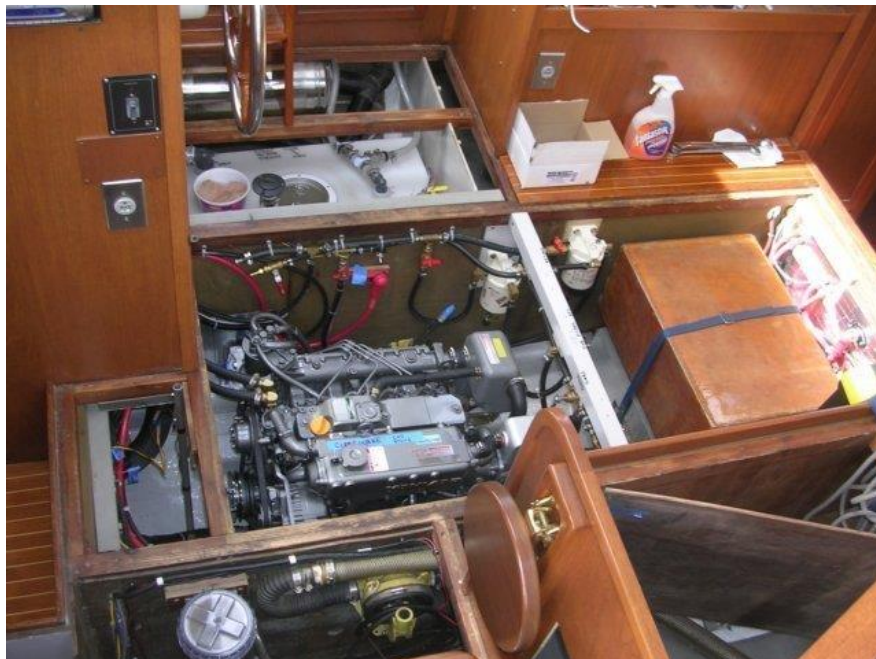
Steps 8 - 37. Install new engine after replacing incorrect senders, making a few (significant) electrical changes

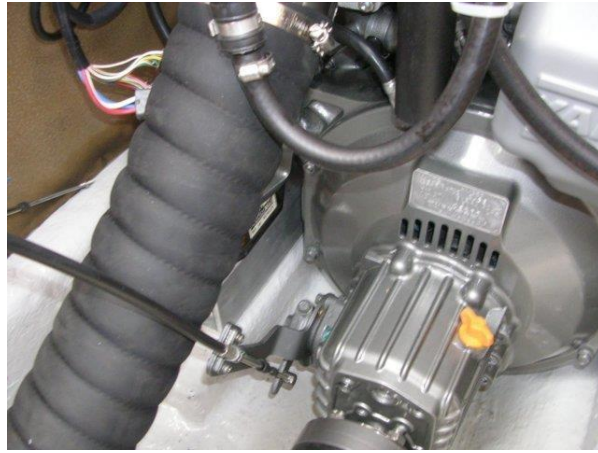
Not sure why, but Yanmar very nicely aligned the gear shift mechanism directly below the 3" exhaust. Fortunately, the exhaust hose needed to make a bend to port, and by rotating the shift mount to tip it aft, things were made to work.

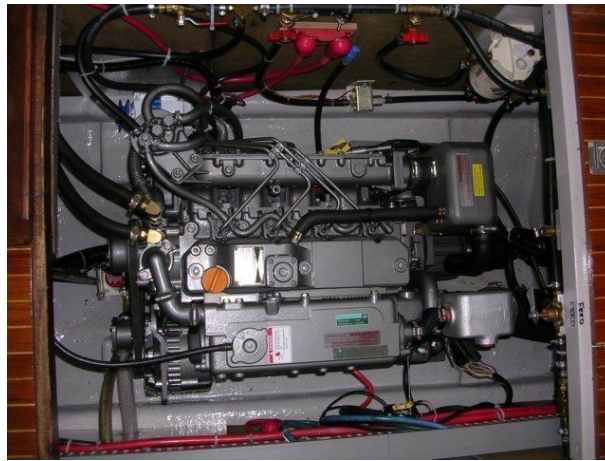
View from above.

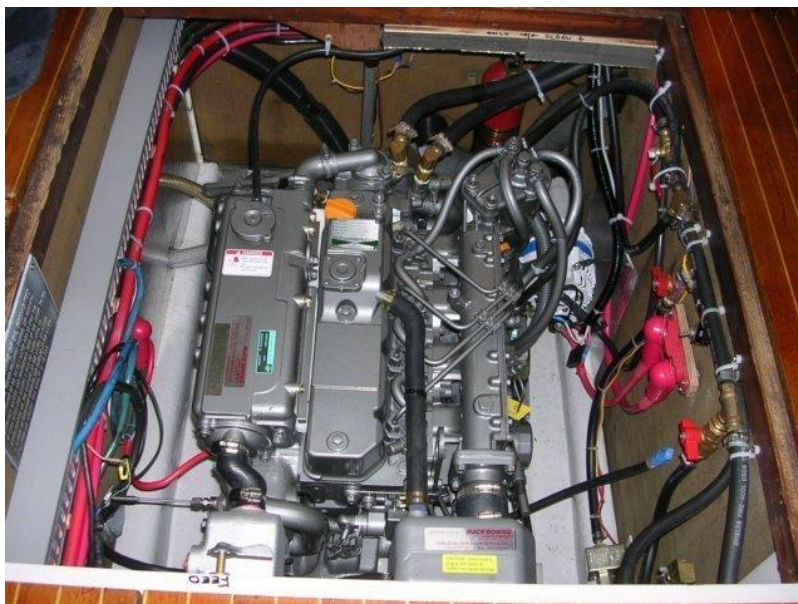
All is well that ends well. The engine mounts had to be swapped out for more flexible ones (e-mail me for details if you are installing a 4JH4) while the engine was in the boat. In reality, that wasn't that much work if you don't mind standing on your head for four hours. It was the usual job with the first three taking very little time and the last one taking the majority of time. The cost and time were worthwhile however. The new engine is 17 dbA quieter, although some additional sound insulation might have contributed to that.

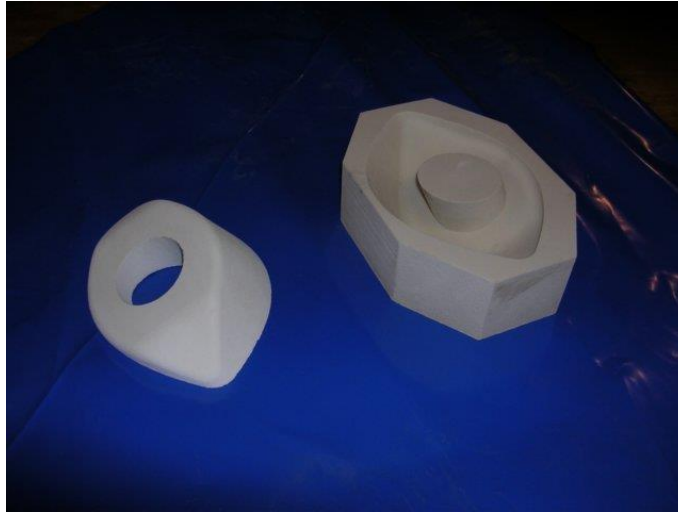
The boat needed a second depth sounder (fish finder). Not being happy with a shoot through the hull one, we wanted one that had direct access to the water. This required an external fairing on the outside of the hull. I have a good idea. Cast one out of epoxy. First print a prototype using a Z-Corporation 3D printer (on left). Then print a mold that can be filled with epoxy (on right).

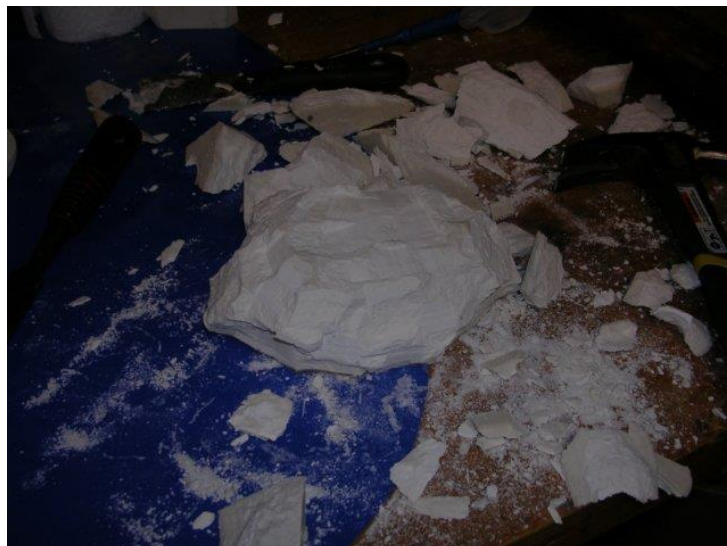
Somebody could have printed the mold a different color than the epoxy that was poured into the mold, but they didn't. Somebody also thought that the epoxy wouldn't adhere to the plaster mold but it did.

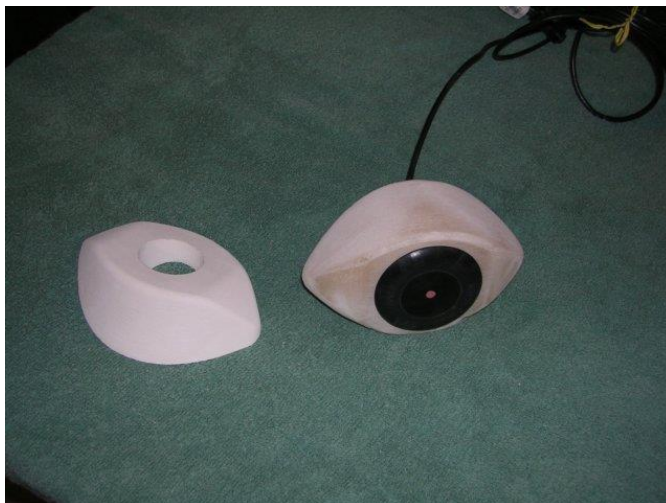
After much work with a chisle and sandpaper, you have an epoxy part. The plaster prototype is on the left, the finished epoxy part on the right.

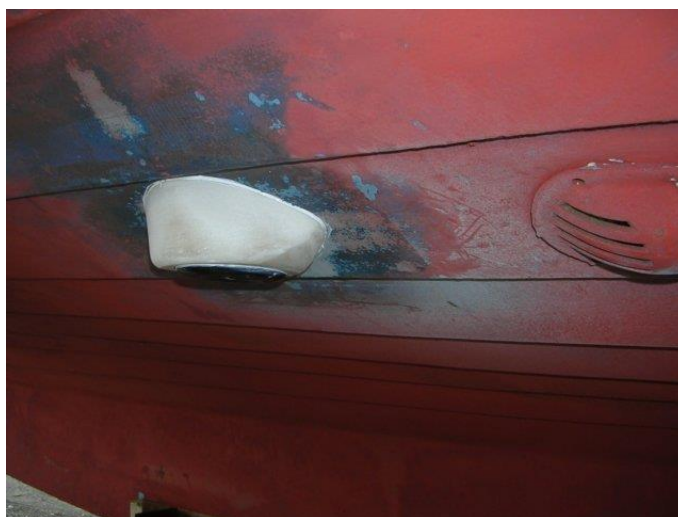
Installed in the boat bottom.

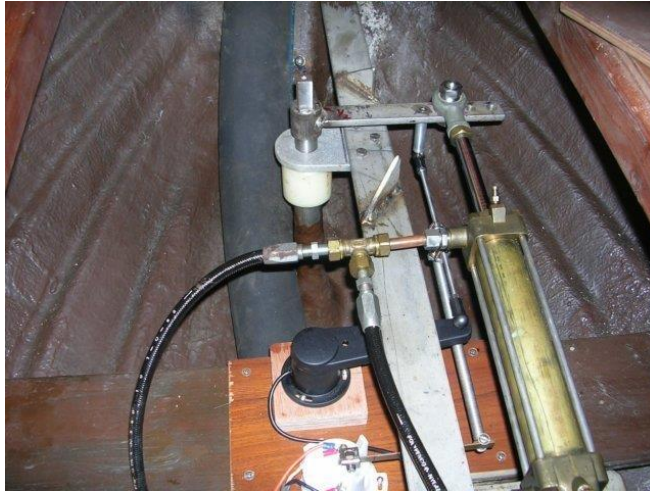
View of the ram and rudder indicator.

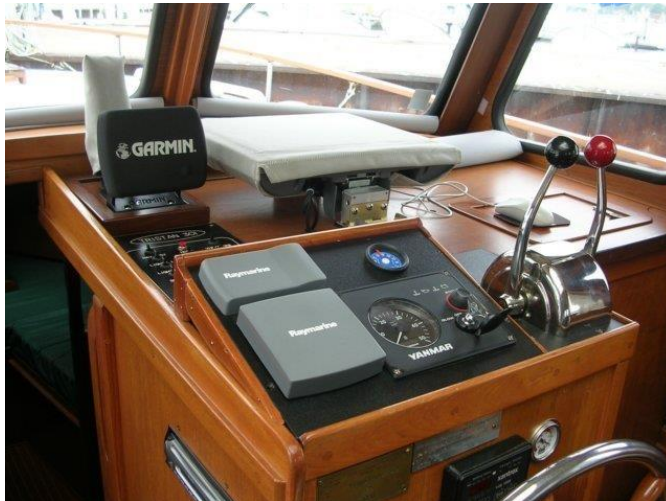
Revision X (lost count) for instruments. Autopilot, wind speed, Yanmar panel as well as Garmin fish finder are new in 2006. The Garmin screen was very nicely placed overhead until it was realized that the LCD screen could not be read even with the backlighting turned to maximum. It only takes a few hours to re-route/re-do all the wiring.

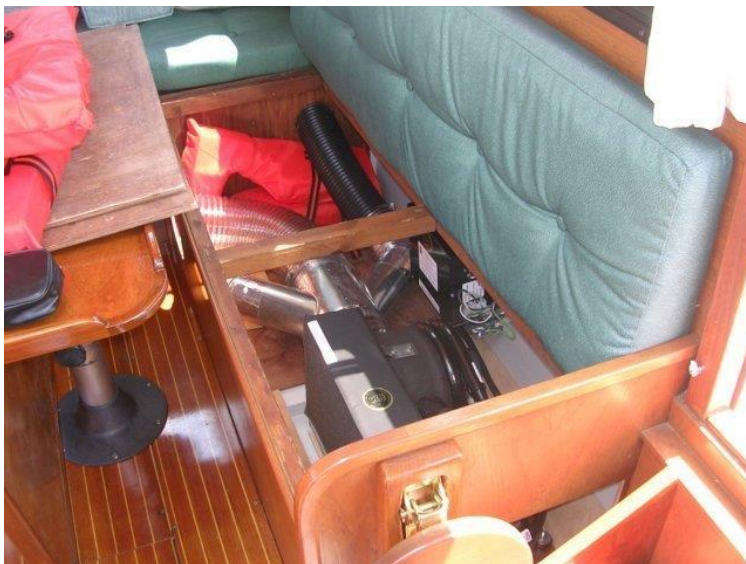
The storage under the port seat was a perfect place to install the air conditioning unit. Since all the through hulls were being replaced during the winter, how much work is it to add one more?

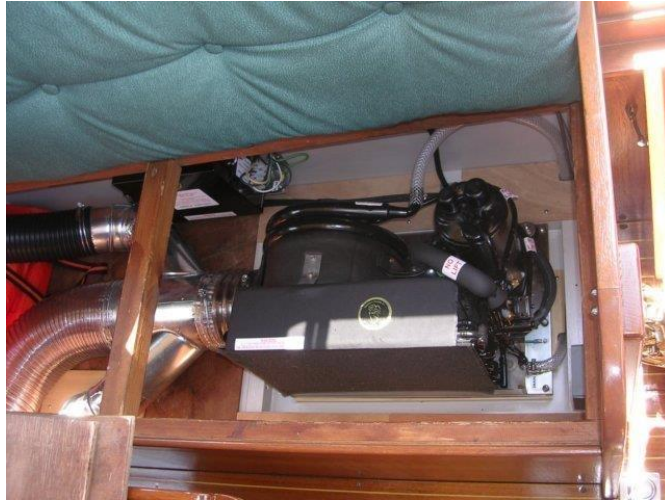
Another view of the air conditioner unit. Since it is a reverse cycle unit, it does provide another heat source at the dock. The Volvo diesel heater that came with the boat is prone to overheating and shutting down. There are three vents: one four inch to the aft cabin, a six inch to the salon and one four inch to the forward cabin.

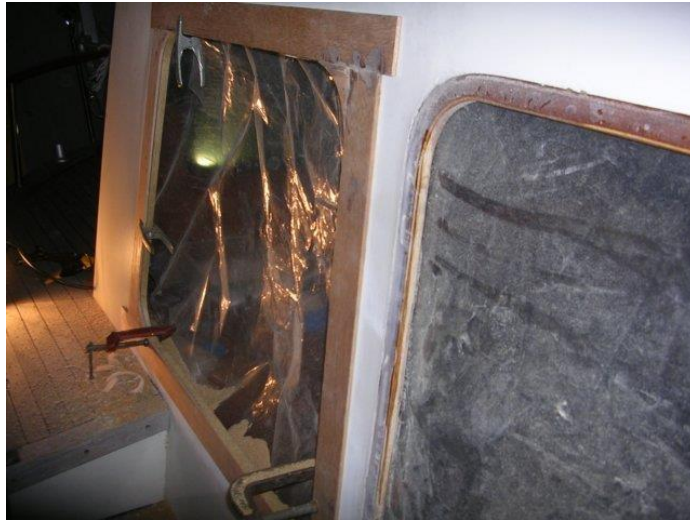
Air movement though the cabin is important. The original ports were non-opening, so while the boat was under cover for the winter, it was thought that this would be an ideal time to address that issue. Of course, the corner radius was incorrect for the new ports, so a jig was made to both straighten the cut outs as well as generate the proper radius by using a router to re-cut the openings.

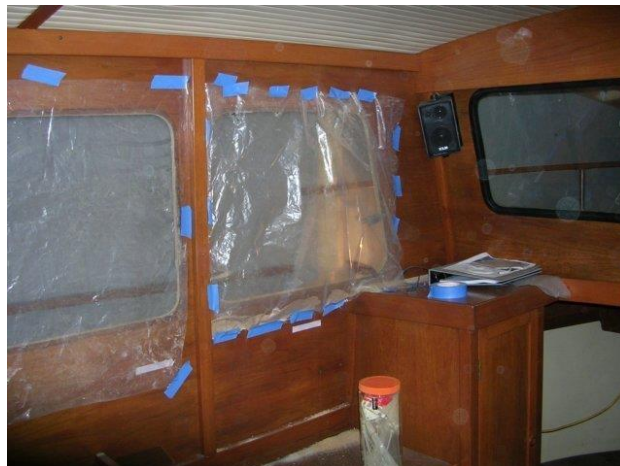
Routers make somewhat of a mess, so the attempt was made to limit the amount of dust and chips entering the cabin. The plastic only got stuck in the router bit once. It removed the entire piece in about 1/100 second.

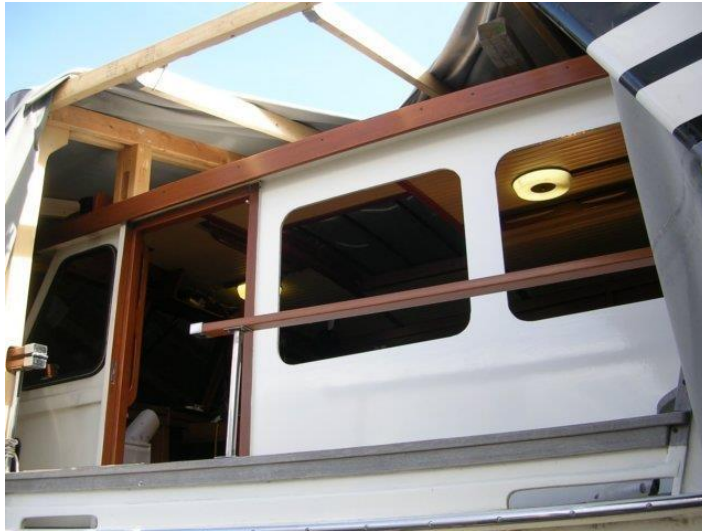
We sanded the outside of the house down to bare wood where the old rubber trim was, removing all traces of the massive amounts of silicone used as sealant. This area was then re-primed, and the house sides repainted with two coats of paint.

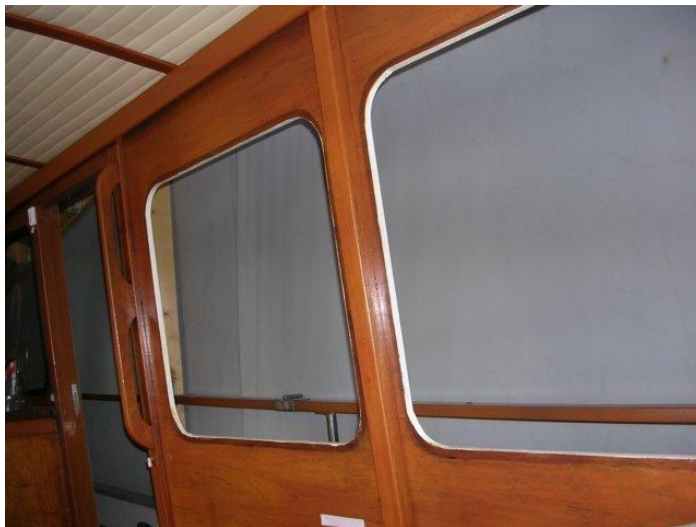
The end grain of the cut outs was saturated with epoxy and then paint. Another coat of Sekins was applied to the inside of the house while we had the chance.

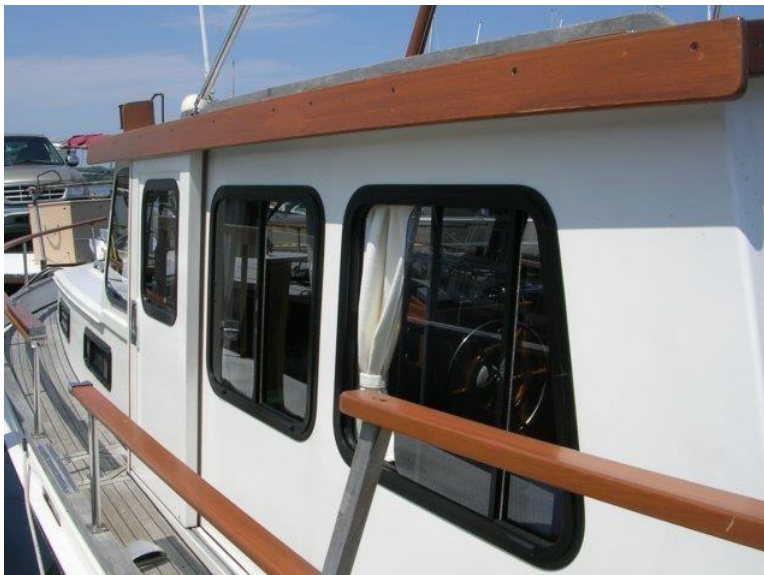
New ports after installation. The cabin doors also got new ports as the old, laminated glass was starting to cloud.

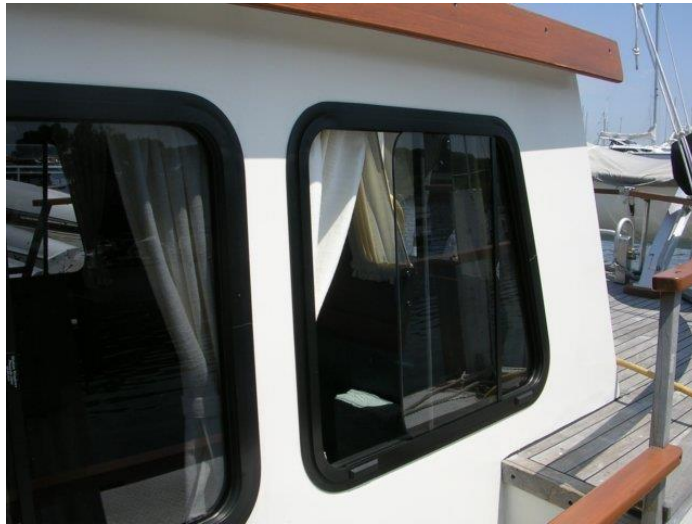
Aft window in the open position. There are sliding screens that are located on the inside track.

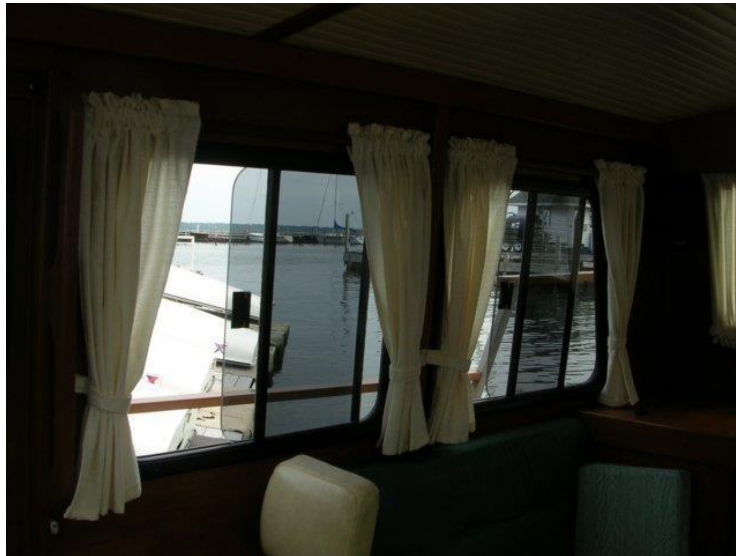
View from inside looking out. The increase in ventilation is significant.

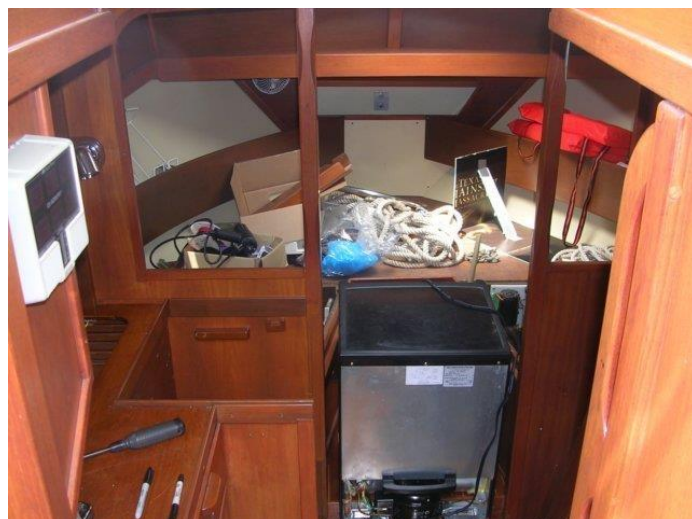
After removing the original propane system and stove, and replacing it with an alcohol system, it was decided to put in a propane cooktop. There is a propane barbecue mounted on the stern rail, and it was reasoned (rationalized) that by having a large propane tank and a propane cooktop below, we could simply run an extension hose back to the barbecue. You only have to make a big mess of the main cabin to get access to locations where you need to drill access holes.

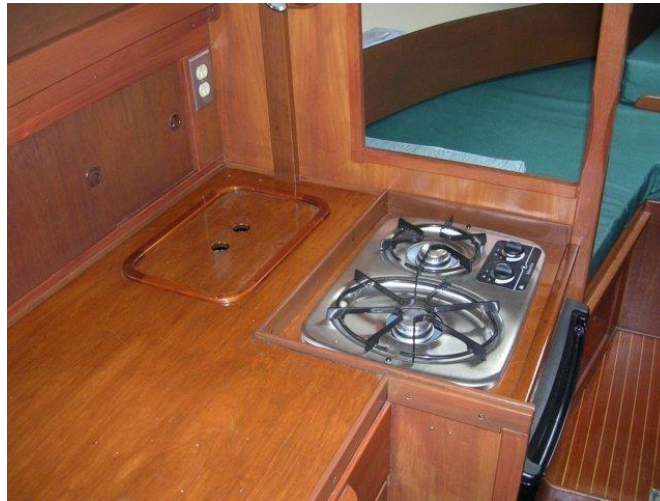
Propane cooktop in place, the refrigerator is underneath.

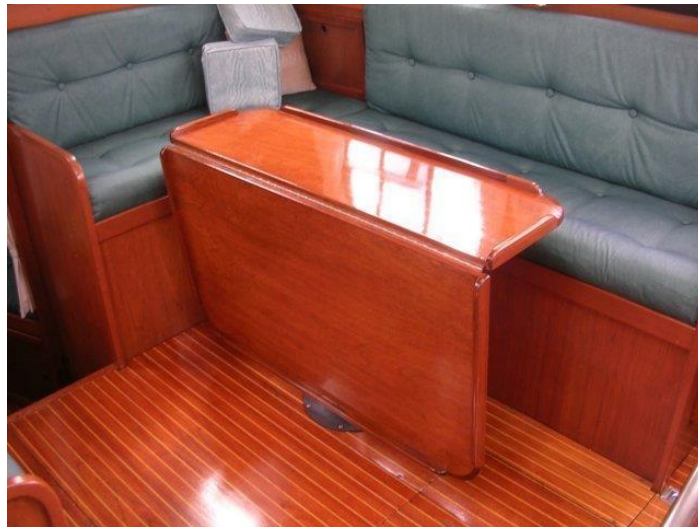
The original table only seated 3 effectively. It was decided that something needed to be done to remedy that situation so that I didn't have to spend the rest of my life holding my plate when we had guests for dinner. This picture is the result. If the table looks a little close to the aft seat, that's because it was, by about 1-1/2 inches. That has been fixed. You can now slide your legs by the dropped down portion.

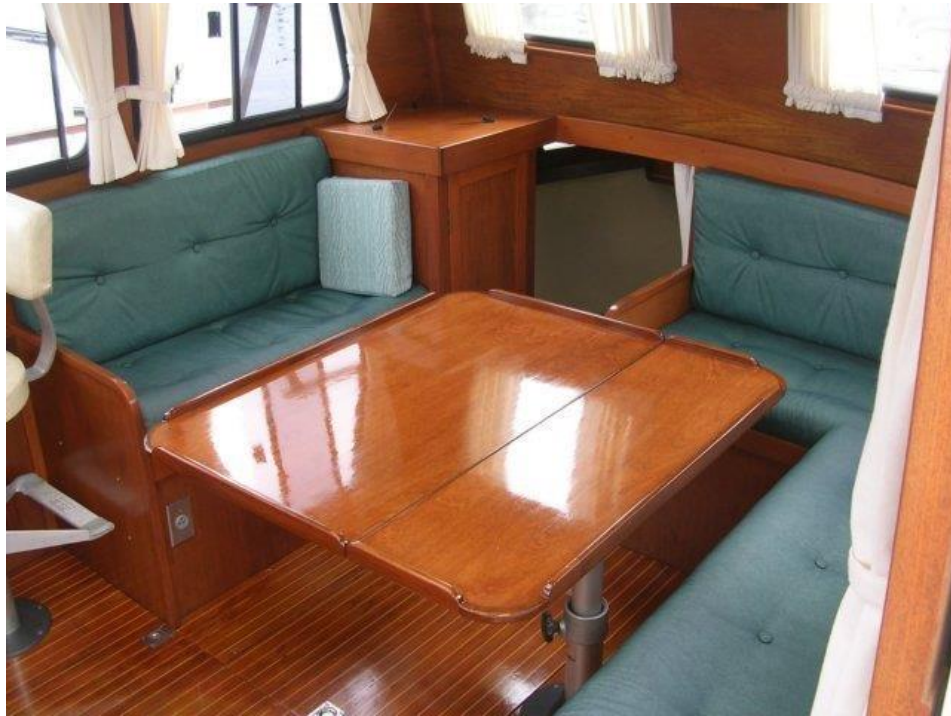
Four for dinner is no longer an issue.
