Projects 2005

CV Joint, Holding Tank, Computer, Aft Steering Station, Covers, Steadying Sail

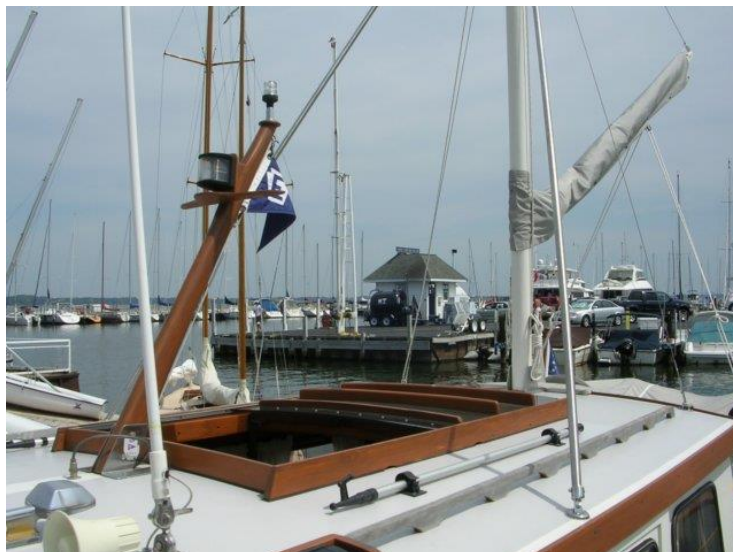
Stainless compression tubes support the spar.

While calculations showed that the compression tubes should be more than adequate for support, wire shrouds were also added as insurance.

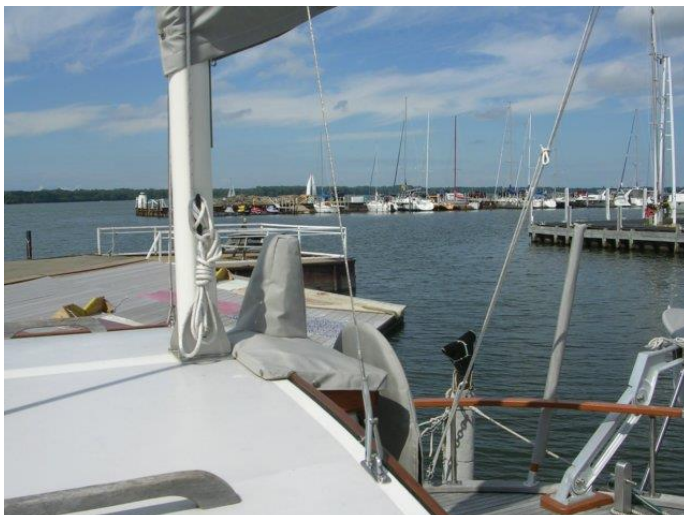
"Temporary" steadying sail. The foot on the new sail will be shortened. We still haven't gotten around to it, but it is still on the list.
