Refit Spring 2003

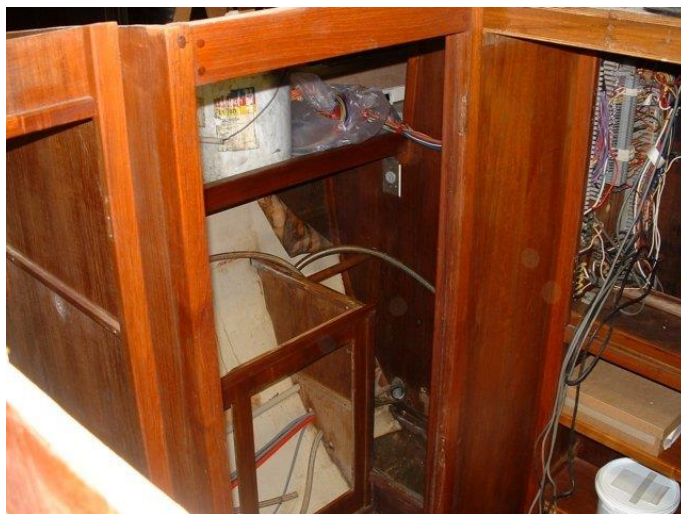
Looking into the head and electrical locker

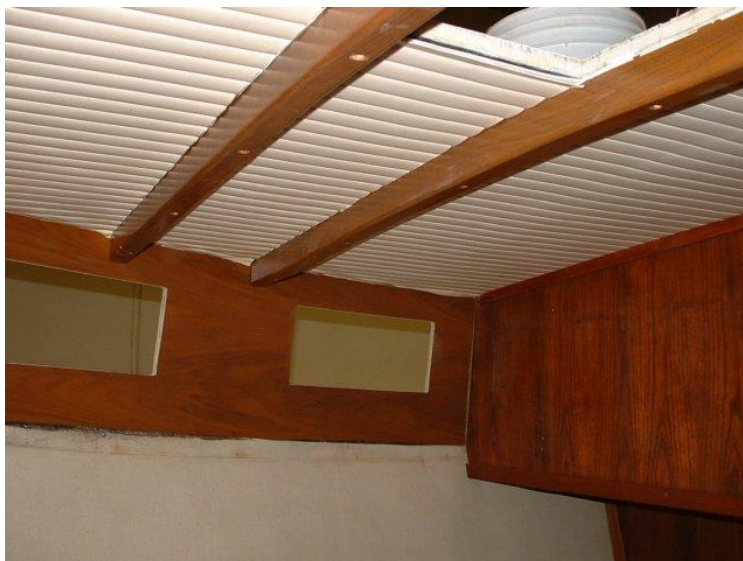
Looking pretty sad in the shop. People who stopped by to visit generally left shaking their heads, probably with good reason.
