Refit Summer 2003

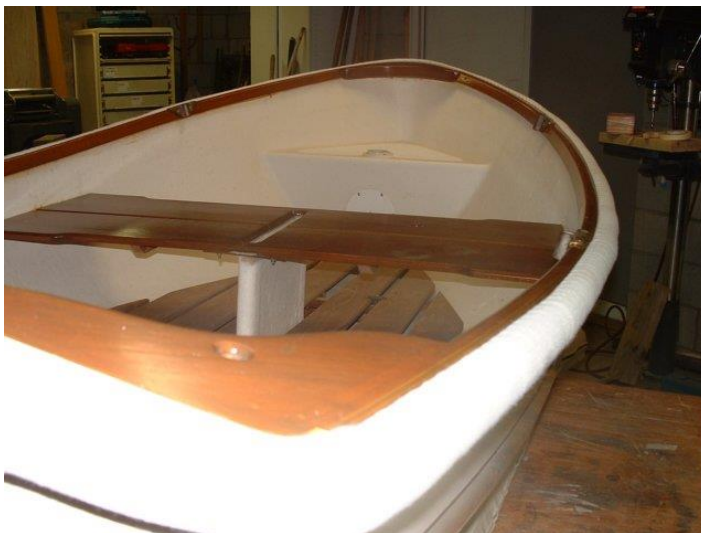
The framework was seated in a thickened epoxy slurry.....

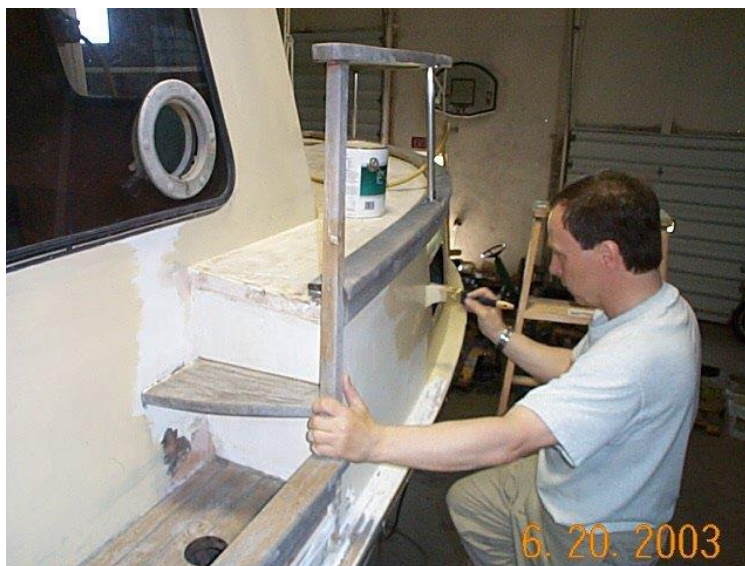
The underside edges of the main salon house were rotten. The rot was dug out, and the wood was replaced with cedar and a white oak cap.
